### NONDESTRUCTIVE TESTING REPORT

工程名称 Project Name: HYSY115FPSO 气量超限改造工程

HYSY115FPSO Gas Excess Reform Project Pipeline Electrical Instrument

报告编号 Report No. : CJP-WR-094-030-MT001-19-052

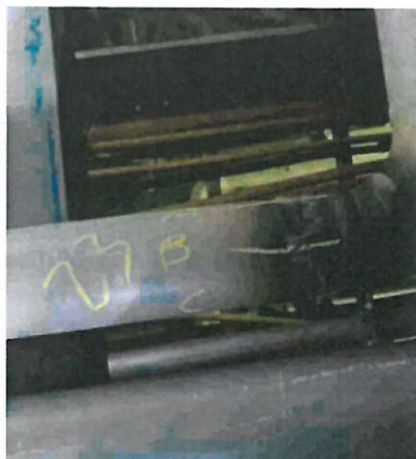
| 2"-DC-66255-A2BZ-HT45 | W011 | 23 | -- | V | GTAW | 188 | -- | -- | Acc |

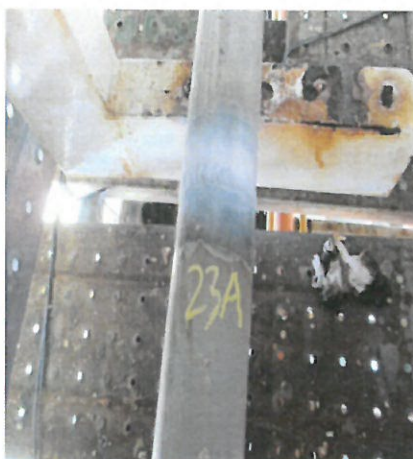
| 2"-DC-66255-A2BZ-HT45 | W011 | 23A | -- | V | GTAW | 188 | -- | -- | Acc |

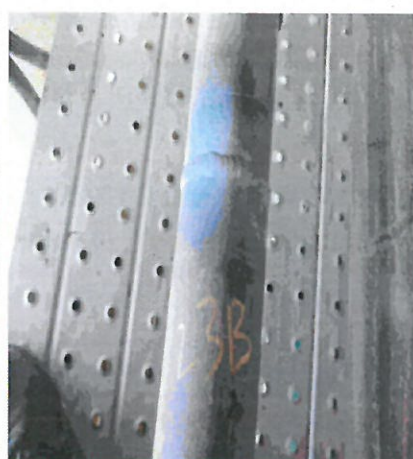
| 2"-DC-66255-A2BZ-HT45 | W011 | 23B | -- | V | GTAW | 188 | -- | -- | Acc |

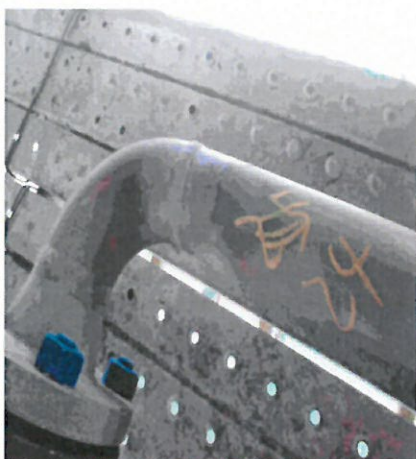
| 2"-DC-66255-A2BZ-HT45 | W011 | 24 | -- | V | GTAW | 188 | -- | -- | Acc |

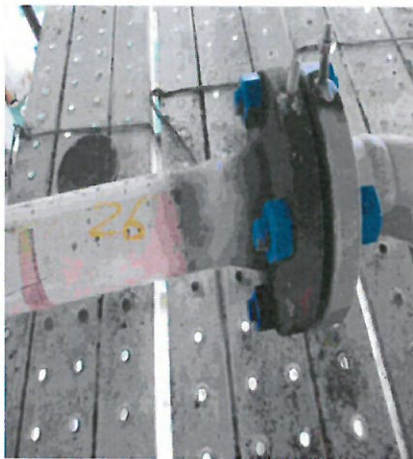
| 2"-DC-66255-A2BZ-HT45 | W011 | 26 | -- | V | GTAW | 188 | -- | -- | Acc |

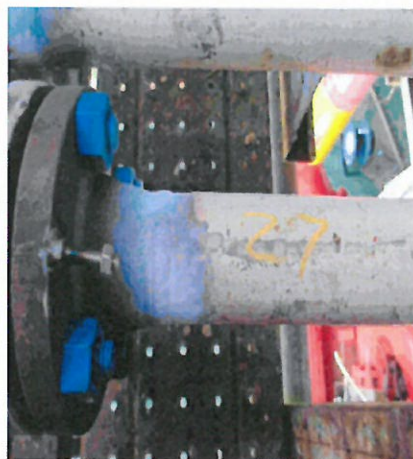
| 2"-FD-32094-A2BZ | W078 | 27 | -- | V | GTAW | 188 | -- | -- | Acc |

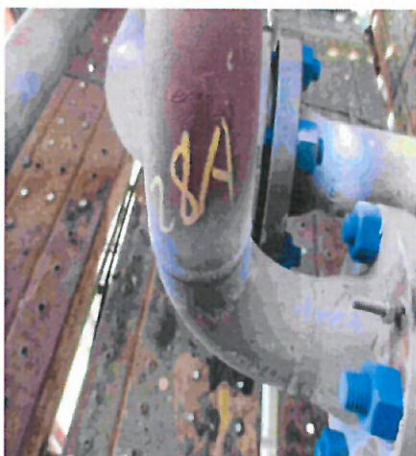
| 2"-FD-32094-A2BZ | W078 | 28A | -- | V | GTAW | 188 | -- | -- | Acc |

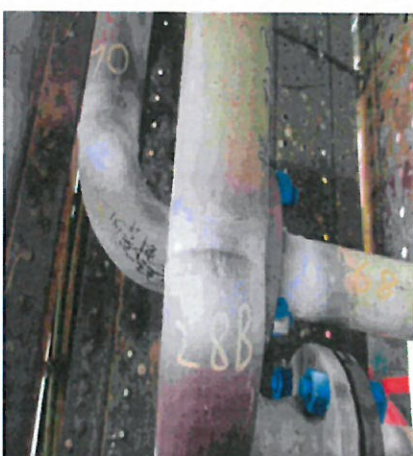
| 2"-FD-32094-A2BZ | W078 | 28B | -- | V | GTAW | 188 | -- | -- | Acc |

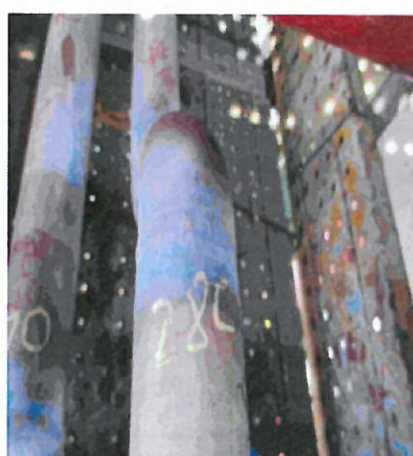
| 2"-FD-32094-A2BZ | W078 | 28C | -- | V | GTAW | 188 | -- | -- | Acc |

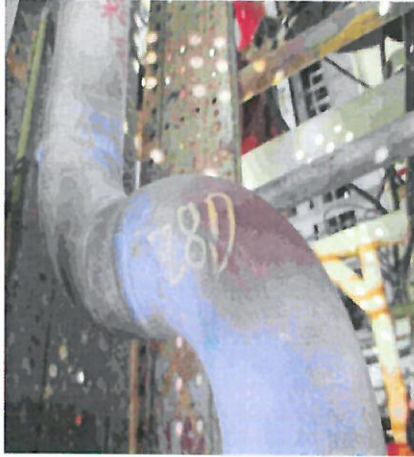
| 2"-FD-32094-A2BZ | W078 | 28D | -- | V | GTAW | 188 | -- | -- | Acc |

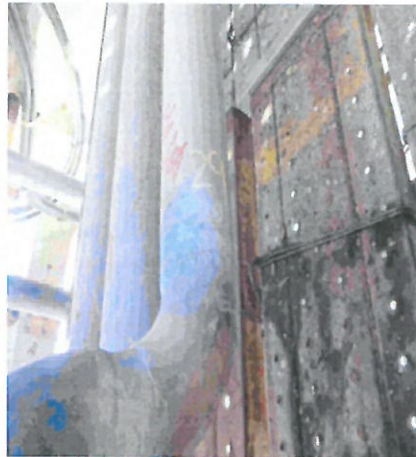
| 2"-FD-32094-A2BZ | W078 | 29 | -- | V | GTAW | 188 | -- | -- | Acc |

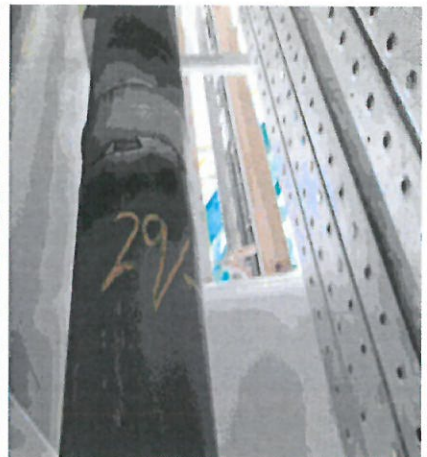
| 2"-FD-32094-A2BZ | W078 | 29A | -- | V | GTAW | 188 | -- | -- | Acc |

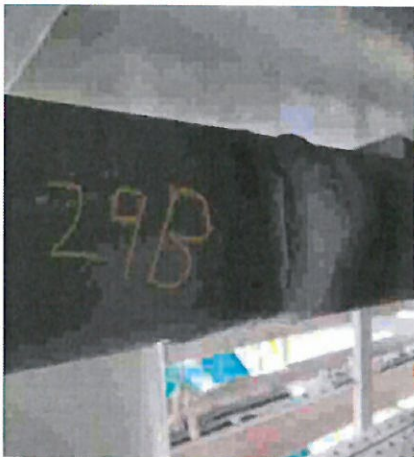
| 工件编号<br>Workpiece No. | 焊工号<br>Welder No. | 焊口号<br>Weld No. | 热处理状态<br>HTS | 坡口形式<br>Groove Form | 焊接方法<br>Welding Process | 焊缝长度<br>W.L. (mm) | 缺陷编号<br>Defect No. | 缺陷性质及大小<br>DNS | 评定意见<br>Judge |
|---|---|---|---|---|---|---|---|---|---|
| 2"-FD-32094-A2BZ | W078 | 29B | -- | V | GTAW | 188 | -- | -- | Acc |

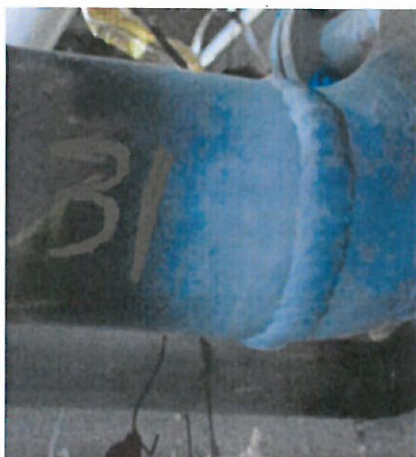
| 工件编号<br>Workpiece No. | 焊工号<br>Welder No. | 焊口号<br>Weld No. | 热处理状态<br>HTS | 坡口形式<br>Groove Form | 焊接方法<br>Welding Process | 焊缝长度<br>W.L. (mm) | 缺陷编号<br>Defect No. | 缺陷性质及大小<br>DNS | 评定意见<br>Judge |
|---|---|---|---|---|---|---|---|---|---|
| 2"-FD-32094-A2BZ | W078 | 31 | -- | V | GTAW | 188 | -- | -- | Acc |

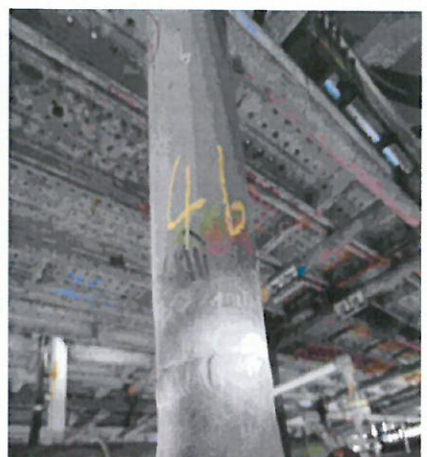
| 工件编号<br>Workpiece No. | 焊工号<br>Welder No. | 焊口号<br>Weld No. | 热处理状态<br>HTS | 坡口形式<br>Groove Form | 焊接方法<br>Welding Process | 焊缝长度<br>W.L. (mm) | 缺陷编号<br>Defect No. | 缺陷性质及大小<br>DNS | 评定意见<br>Judge |
|---|---|---|---|---|---|---|---|---|---|
| 2"-WF-42094-A2BZ | W011 | 46 | -- | V | GTAW | 188 | -- | -- | Acc |

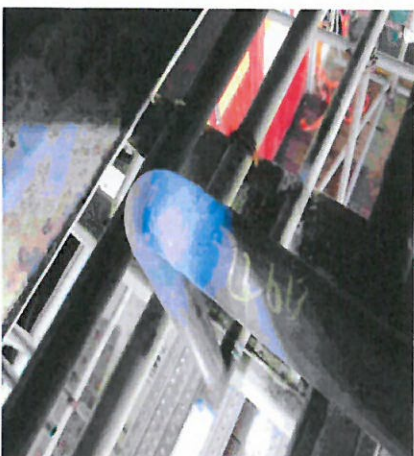
| 工件编号<br>Workpiece No. | 焊工号<br>Welder No. | 焊口号<br>Weld No. | 热处理状态<br>HTS | 坡口形式<br>Groove Form | 焊接方法<br>Welding Process | 焊缝长度<br>W.L. (mm) | 缺陷编号<br>Defect No. | 缺陷性质及大小<br>DNS | 评定意见<br>Judge |
|---|---|---|---|---|---|---|---|---|---|
| 2"-WF-42094-A2BZ | W011 | 46B | -- | V | GTAW | 188 | -- | -- | Acc |

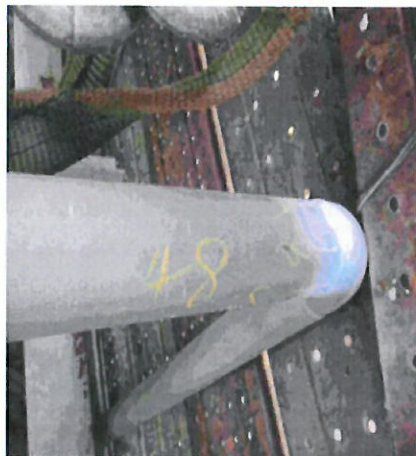
| 工件编号<br>Workpiece No. | 焊工号<br>Welder No. | 焊口号<br>Weld No. | 热处理状态<br>HTS | 坡口形式<br>Groove Form | 焊接方法<br>Welding Process | 焊缝长度<br>W.L. (mm) | 缺陷编号<br>Defect No. | 缺陷性质及大小<br>DNS | 评定意见<br>Judge |
|---|---|---|---|---|---|---|---|---|---|
| 2"-WF-42094-A2BZ | W011 | 48 | -- | V | GTAW | 188 | -- | -- | Acc |

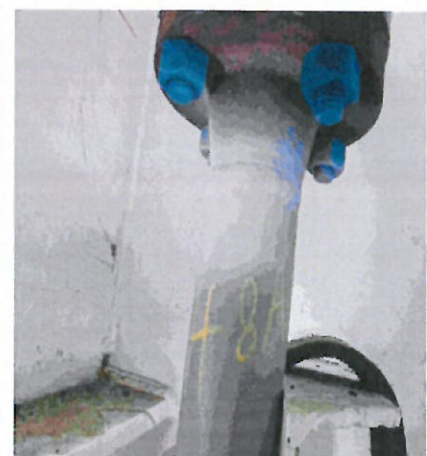
| 工件编号<br>Workpiece No. | 焊工号<br>Welder No. | 焊口号<br>Weld No. | 热处理状态<br>HTS | 坡口形式<br>Groove Form | 焊接方法<br>Welding Process | 焊缝长度<br>W.L. (mm) | 缺陷编号<br>Defect No. | 缺陷性质及大小<br>DNS | 评定意见<br>Judge |
|---|---|---|---|---|---|---|---|---|---|
| 2"-WF-42094-A2BZ | W011 | 48A | -- | V | GTAW | 188 | -- | -- | Acc |

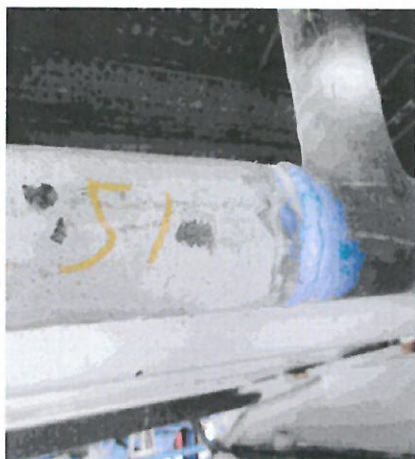
| 工件编号<br>Workpiece No. | 焊工号<br>Welder No. | 焊口号<br>Weld No. | 热处理状态<br>HTS | 坡口形式<br>Groove Form | 焊接方法<br>Welding Process | 焊缝长度<br>W.L. (mm) | 缺陷编号<br>Defect No. | 缺陷性质及大小<br>DNS | 评定意见<br>Judge |
|---|---|---|---|---|---|---|---|---|---|
| 2"-WF-42094-A2BZ | W011 | 51 | -- | V | GTAW | 188 | -- | -- | Acc |

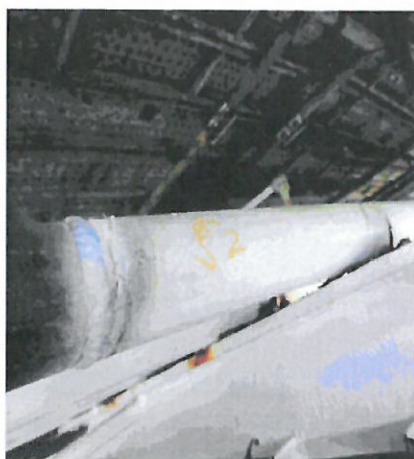
| 工件编号<br>Workpiece No. | 焊工号<br>Welder No. | 焊口号<br>Weld No. | 热处理状态<br>HTS | 坡口形式<br>Groove Form | 焊接方法<br>Welding Process | 焊缝长度<br>W.L. (mm) | 缺陷编号<br>Defect No. | 缺陷性质及大小<br>DNS | 评定意见<br>Judge |
|---|---|---|---|---|---|---|---|---|---|
| 2"-WF-42094-A2BZ | W011 | 52 | -- | V | GTAW | 188 | -- | -- | Acc |

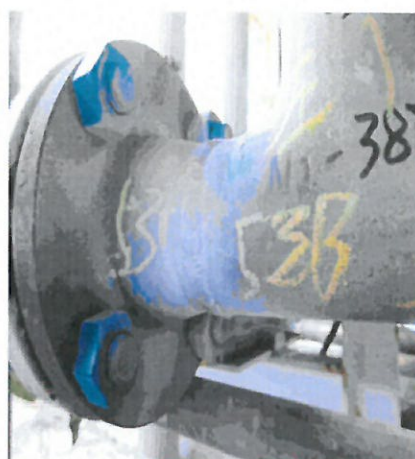
| 工件编号<br>Workpiece No. | 焊工号<br>Welder No. | 焊口号<br>Weld No. | 热处理状态<br>HTS | 坡口形式<br>Groove Form | 焊接方法<br>Welding Process | 焊缝长度<br>W.L. (mm) | 缺陷编号<br>Defect No. | 缺陷性质及大小<br>DNS | 评定意见<br>Judge |
|---|---|---|---|---|---|---|---|---|---|
| 2"-CR-70155-A2BZ-HT45 | W036 | 53B | -- | V | GTAW | 188 | -- | -- | Acc |

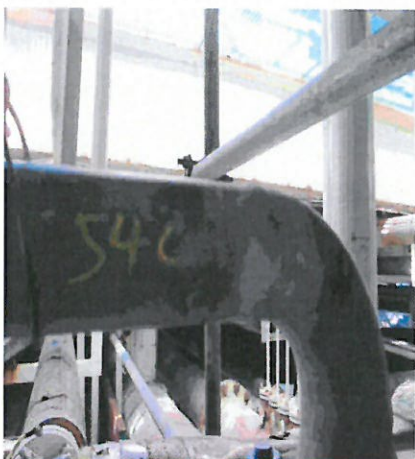
| 工件编号<br>Workpiece No. | 焊工号<br>Welder No. | 焊口号<br>Weld No. | 热处理状态<br>HTS | 坡口形式<br>Groove Form | 焊接方法<br>Welding Process | 焊缝长度<br>W.L. (mm) | 缺陷编号<br>Defect No. | 缺陷性质及大小<br>DNS | 评定意见<br>Judge |
|---|---|---|---|---|---|---|---|---|---|
| 2"-CR-70155-A2BZ-HT45 | W036 | 54C | -- | V | GTAW | 188 | -- | -- | Acc |

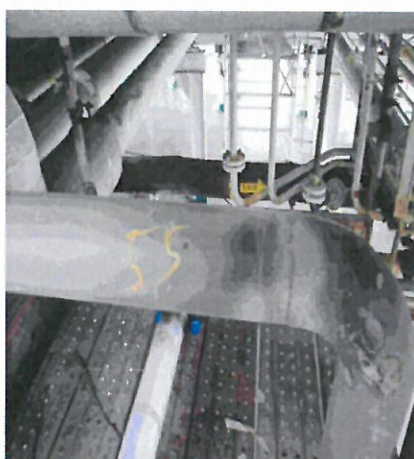
| 工件编号<br>Workpiece No. | 焊工号<br>Welder No. | 焊口号<br>Weld No. | 热处理状态<br>HTS | 坡口形式<br>Groove Form | 焊接方法<br>Welding Process | 焊缝长度<br>W.L. (mm) | 缺陷编号<br>Defect No. | 缺陷性质及大小<br>DNS | 评定意见<br>Judge |
|---|---|---|---|---|---|---|---|---|---|
| 2"-CR-70155-A2BZ-HT45 | W036 | 55 | -- | V | GTAW | 188 | -- | -- | Acc |

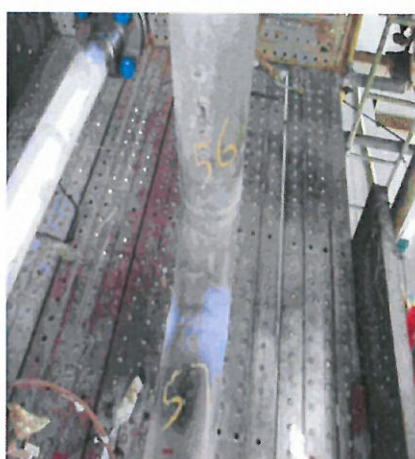
56/57

| 工件编号<br>Workpiece No. | 焊工号<br>Welder No. | 焊口号<br>Weld No. | 热处理状态<br>HTS | 坡口形式<br>Groove Form | 焊接方法<br>Welding Process | 焊缝长度<br>W.L. (mm) | 缺陷编号<br>Defect No. | 缺陷性质及大小<br>DNS | 评定意见<br>Judge |
|---|---|---|---|---|---|---|---|---|---|
| 2"-CR-70155-A2BZ-HT45 | W036 | 56 | -- | V | GTAW | 188 | -- | -- | Acc |
| 2"-CR-70155-A2BZ-HT45 | W036 | 57 | -- | V | GTAW | 188 | -- | -- | Acc |

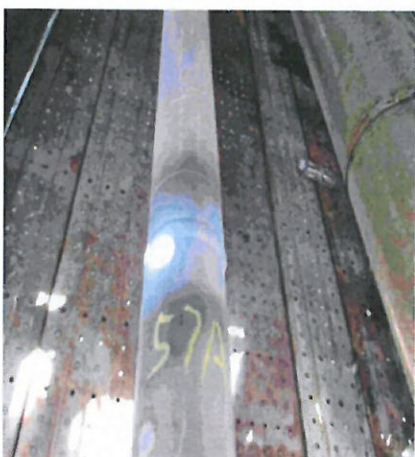
| 工件编号<br>Workpiece No. | 焊工号<br>Welder No. | 焊口号<br>Weld No. | 热处理状态<br>HTS | 坡口形式<br>Groove Form | 焊接方法<br>Welding Process | 焊缝长度<br>W.L. (mm) | 缺陷编号<br>Defect No. | 缺陷性质及大小<br>DNS | 评定意见<br>Judge |
|---|---|---|---|---|---|---|---|---|---|
| 2"-CR-70155-A2BZ-HT45 | W036 | 57A | -- | V | GTAW | 188 | -- | -- | Acc |

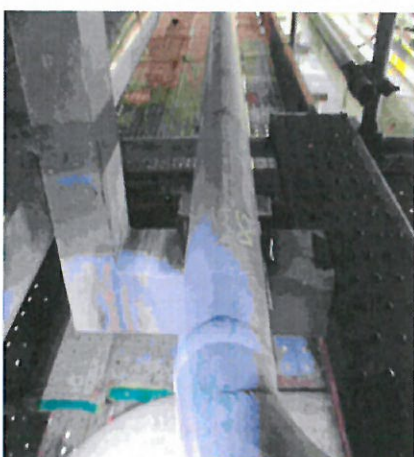
| 工件编号<br>Workpiece No. | 焊工号<br>Welder No. | 焊口号<br>Weld No. | 热处理状态<br>HTS | 坡口形式<br>Groove Form | 焊接方法<br>Welding Process | 焊缝长度<br>W.L. (mm) | 缺陷编号<br>Defect No. | 缺陷性质及大小<br>DNS | 评定意见<br>Judge |
|---|---|---|---|---|---|---|---|---|---|
| 2"-CR-70155-A2BZ-HT45 | W036 | 58 | -- | V | GTAW | 188 | -- | -- | Acc |

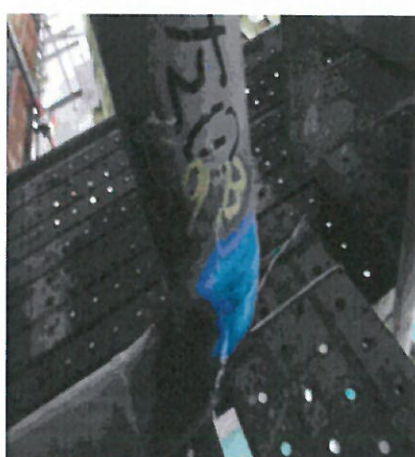
| 工件编号<br>Workpiece No. | 焊工号<br>Welder No. | 焊口号<br>Weld No. | 热处理状态<br>HTS | 坡口形式<br>Groove Form | 焊接方法<br>Welding Process | 焊缝长度<br>W.L. (mm) | 缺陷编号<br>Defect No. | 缺陷性质及大小<br>DNS | 评定意见<br>Judge |
|---|---|---|---|---|---|---|---|---|---|
| 2"-CR-70155-A2BZ-HT45 | W036 | 59B | -- | V | GTAW | 188 | -- | -- | Acc |

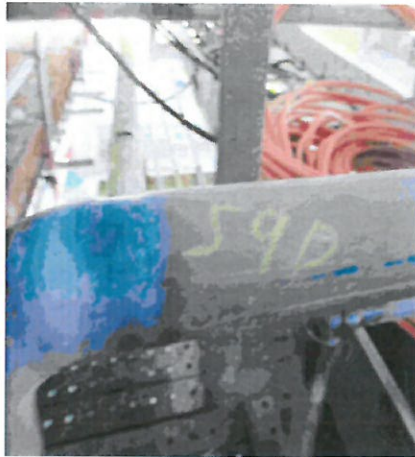
| 工件编号<br>Workpiece No. | 焊工号<br>Welder No. | 焊口号<br>Weld No. | 热处理状态<br>HTS | 坡口形式<br>Groove Form | 焊接方法<br>Welding Process | 焊缝长度<br>W.L. (mm) | 缺陷编号<br>Defect No. | 缺陷性质及大小<br>DNS | 评定意见<br>Judge |
|---|---|---|---|---|---|---|---|---|---|
| 2"-CR-70155-A2BZ-HT45 | W036 | 59D | -- | V | GTAW | 188 | -- | -- | Acc |

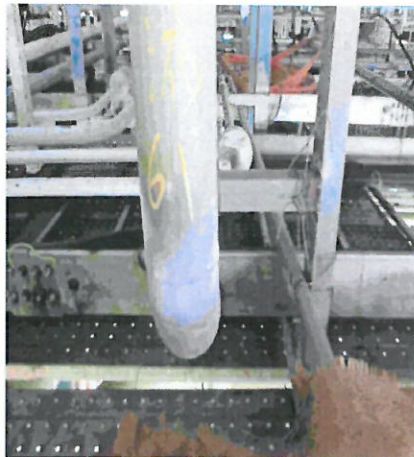
| 工件编号<br>Workpiece No. | 焊工号<br>Welder No. | 焊口号<br>Weld No. | 热处理状态<br>HTS | 坡口形式<br>Groove Form | 焊接方法<br>Welding Process | 焊缝长度<br>W.L. (mm) | 缺陷编号<br>Defect No. | 缺陷性质及大小<br>DNS | 评定意见<br>Judge |
|---|---|---|---|---|---|---|---|---|---|
| 2"-CR-70155-A2BZ-HT45 | W036 | 61 | -- | V | GTAW | 188 | -- | -- | Acc |

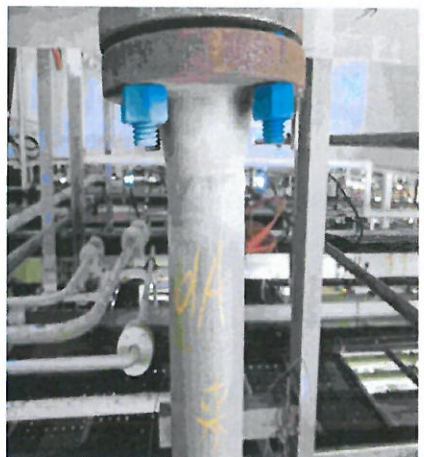
| 工件编号<br>Workpiece No. | 焊工号<br>Welder No. | 焊口号<br>Weld No. | 热处理状态<br>HTS | 坡口形式<br>Groove Form | 焊接方法<br>Welding Process | 焊缝长度<br>W.L. (mm) | 缺陷编号<br>Defect No. | 缺陷性质及大小<br>DNS | 评定意见<br>Judge |
|---|---|---|---|---|---|---|---|---|---|
| 2"-CR-70155-A2BZ-HT45 | W036 | 61A | -- | V | GTAW | 188 | -- | -- | Acc |

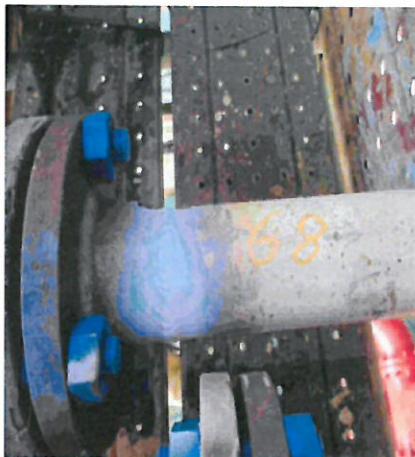
| 工件编号<br>Workpiece No. | 焊工号<br>Welder No. | 焊口号<br>Weld No. | 热处理状态<br>HTS | 坡口形式<br>Groove Form | 焊接方法<br>Welding Process | 焊缝长度<br>W. L ( mm ) | 缺陷编号<br>Defect No. | 缺陷性质及大小<br>DNS | 评定意见<br>Judge |
|---|---|---|---|---|---|---|---|---|---|
| 2"-N2-38049-A2BZ | W036 | 68 | --- | V | GTAW | 188 | --- | --- | Acc |

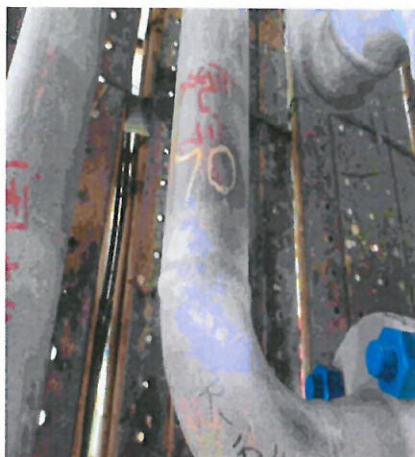
| 工件编号<br>Workpiece No. | 焊工号<br>Welder No. | 焊口号<br>Weld No. | 热处理状态<br>HTS | 坡口形式<br>Groove Form | 焊接方法<br>Welding Process | 焊缝长度<br>W. L ( mm ) | 缺陷编号<br>Defect No. | 缺陷性质及大小<br>DNS | 评定意见<br>Judge |
|---|---|---|---|---|---|---|---|---|---|
| 2"-N2-38049-A2BZ | W036 | 70 | --- | V | GTAW | 188 | --- | --- | Acc |

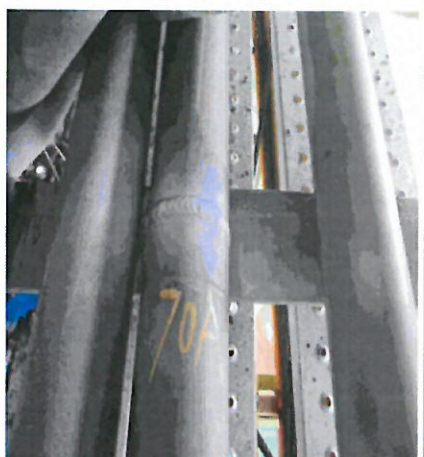
| 工件编号<br>Workpiece No. | 焊工号<br>Welder No. | 焊口号<br>Weld No. | 热处理状态<br>HTS | 坡口形式<br>Groove Form | 焊接方法<br>Welding Process | 焊缝长度<br>W. L ( mm ) | 缺陷编号<br>Defect No. | 缺陷性质及大小<br>DNS | 评定意见<br>Judge |
|---|---|---|---|---|---|---|---|---|---|
| 2"-N2-38049-A2BZ | W036 | 70A | --- | V | GTAW | 188 | --- | --- | Acc |

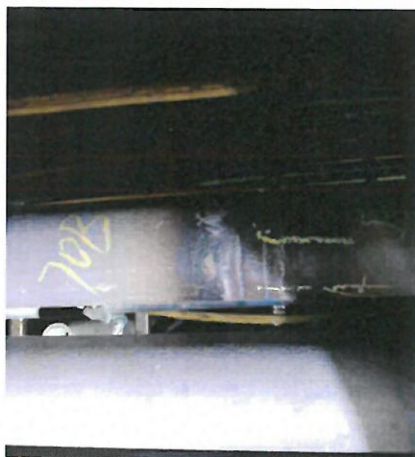
| 工件编号<br>Workpiece No. | 焊工号<br>Welder No. | 焊口号<br>Weld No. | 热处理状态<br>HTS | 坡口形式<br>Groove Form | 焊接方法<br>Welding Process | 焊缝长度<br>W. L ( mm ) | 缺陷编号<br>Defect No. | 缺陷性质及大小<br>DNS | 评定意见<br>Judge |
|---|---|---|---|---|---|---|---|---|---|
| 2"-N2-38049-A2BZ | W036 | 70B | --- | V | GTAW | 188 | --- | --- | Acc |

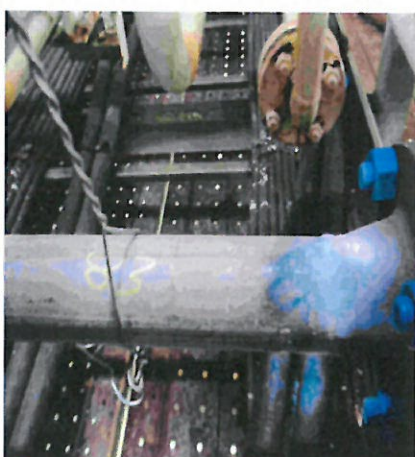
| 工件编号<br>Workpiece No. | 焊工号<br>Welder No. | 焊口号<br>Weld No. | 热处理状态<br>HTS | 坡口形式<br>Groove Form | 焊接方法<br>Welding Process | 焊缝长度<br>W. L ( mm ) | 缺陷编号<br>Defect No. | 缺陷性质及大小<br>DNS | 评定意见<br>Judge |
|---|---|---|---|---|---|---|---|---|---|
| 2"-CR-70257-A2BZ-HT45 | W078 | 83 | --- | V | GTAW | 188 | --- | --- | Acc |

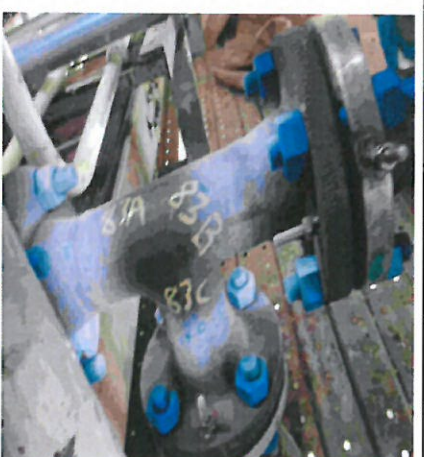
83A/83B/83C

| 工件编号<br>Workpiece No. | 焊工号<br>Welder No. | 焊口号<br>Weld No. | 热处理状态<br>HTS | 坡口形式<br>Groove Form | 焊接方法<br>Welding Process | 焊缝长度<br>W. L ( mm ) | 缺陷编号<br>Defect No. | 缺陷性质及大小<br>DNS | 评定意见<br>Judge |
|---|---|---|---|---|---|---|---|---|---|
| 2"-CR-70257-A2BZ-HT45 | W078 | 83A | --- | V | GTAW | 188 | --- | --- | Acc |
| 2"-CR-70257-A2BZ-HT45 | W078 | 83B | --- | V | GTAW | 188 | --- | --- | Acc |
| 2"-CR-70257-A2BZ-HT45 | W078 | 83C | --- | V | GTAW | 188 | --- | --- | Acc |

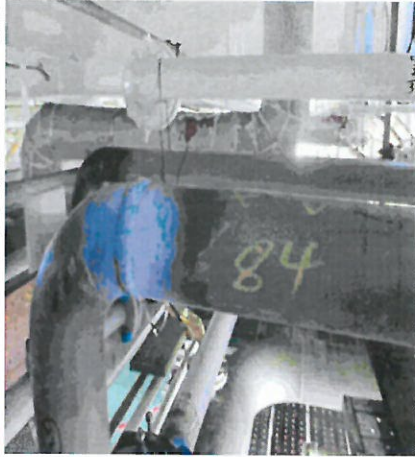
| 工件编号<br>Workpiece No. | 焊工号<br>Welder No. | 焊口号<br>Weld No. | 热处理状态<br>HTS | 坡口形式<br>Groove Form | 焊接方法<br>Welding Process | 焊缝长度<br>W. L ( mm ) | 缺陷编号<br>Defect No. | 缺陷性质及大小<br>DNS | 评定意见<br>Judge |
|---|---|---|---|---|---|---|---|---|---|
| 2"-CR-70257-A2BZ-HT45 | W078 | 84 | --- | V | GTAW | 188 | --- | --- | Acc |

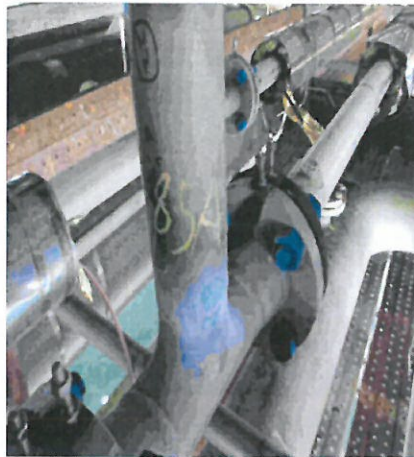
| 工件编号<br>Workpiece No. | 焊工号<br>Welder No. | 焊口号<br>Weld No. | 热处理状态<br>HTS | 坡口形式<br>Groove Form | 焊接方法<br>Welding Process | 焊缝长度<br>W. L ( mm ) | 缺陷编号<br>Defect No. | 缺陷性质及大小<br>DNS | 评定意见<br>Judge |
|---|---|---|---|---|---|---|---|---|---|
| 2"-CR-70257-A2BZ-HT45 | W078 | 85A | --- | V | GTAW | 188 | --- | --- | Acc |

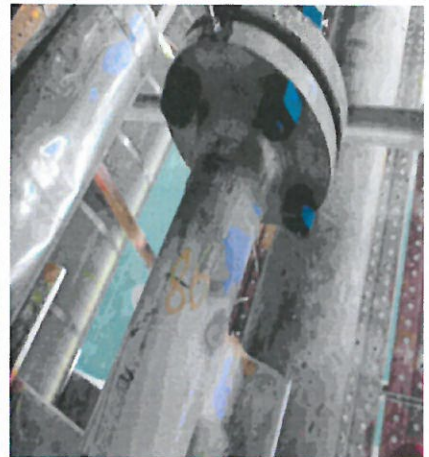
| 工件编号<br>Workpiece No. | 焊工号<br>Welder No. | 焊口号<br>Weld No. | 热处理状态<br>HTS | 坡口形式<br>Groove Form | 焊接方法<br>Welding Process | 焊缝长度<br>W. L ( mm ) | 缺陷编号<br>Defect No. | 缺陷性质及大小<br>DNS | 评定意见<br>Judge |
|---|---|---|---|---|---|---|---|---|---|
| 2"-CR-70257-A2BZ-HT45 | W078 | 86 | --- | V | GTAW | 188 | --- | --- | Acc |

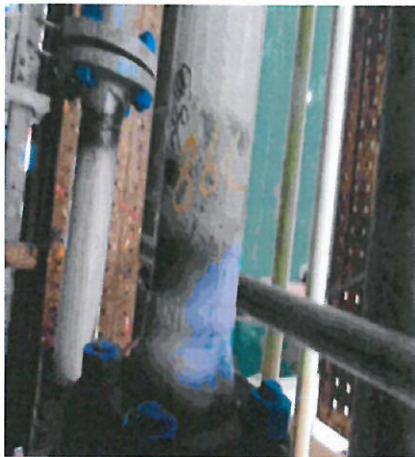
| 工件编号<br>Workpiece No. | 焊工号<br>Welder No. | 焊口号<br>Weld No. | 热处理状态<br>HTS | 坡口形式<br>Groove Form | 焊接方法<br>Welding Process | 焊缝长度<br>W. L ( mm ) | 缺陷编号<br>Defect No. | 缺陷性质及大小<br>DNS | 评定意见<br>Judge |
|---|---|---|---|---|---|---|---|---|---|
| 2"-CR-70257-A2BZ-HT45 | W078 | 86C | --- | V | GTAW | 188 | --- | --- | Acc |

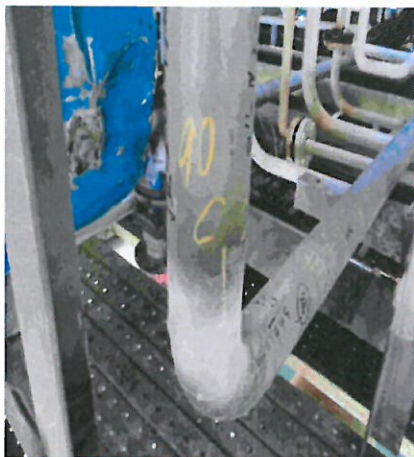
| 工件编号<br>Workpiece No. | 焊工号<br>Welder No. | 焊口号<br>Weld No. | 热处理状态<br>HTS | 坡口形式<br>Groove Form | 焊接方法<br>Welding Process | 焊缝长度<br>W. L ( mm ) | 缺陷编号<br>Defect No. | 缺陷性质及大小<br>DNS | 评定意见<br>Judge |
|---|---|---|---|---|---|---|---|---|---|
| 2"-CR-70156-A2BZ-HT45 | W036 | 90 | --- | V | GTAW | 188 | --- | --- | Acc |

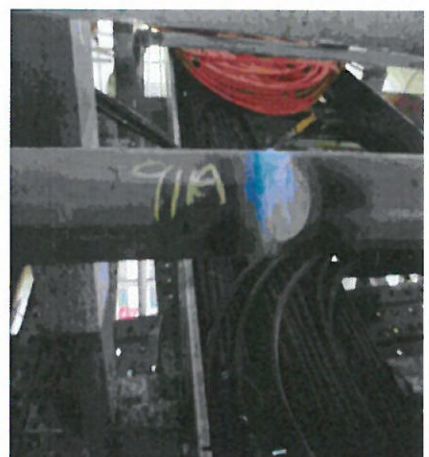
| 工件编号<br>Workpiece No. | 焊工号<br>Welder No. | 焊口号<br>Weld No. | 热处理状态<br>HTS | 坡口形式<br>Groove Form | 焊接方法<br>Welding Process | 焊缝长度<br>W. L ( mm ) | 缺陷编号<br>Defect No. | 缺陷性质及大小<br>DNS | 评定意见<br>Judge |
|---|---|---|---|---|---|---|---|---|---|
| 2"-CR-70156-A2BZ-HT45 | W036 | 91A | --- | V | GTAW | 188 | --- | --- | Acc |

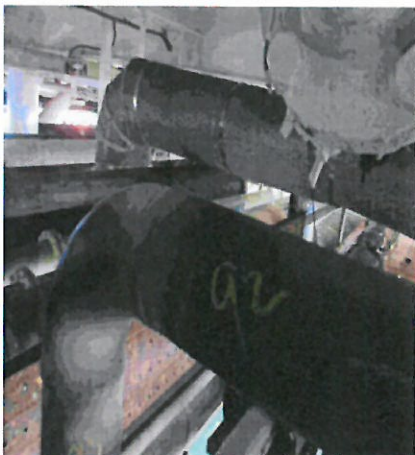
| 工件编号<br>Workpiece No. | 焊工号<br>Welder No. | 焊口号<br>Weld No. | 热处理状态<br>HTS | 坡口形式<br>Groove Form | 焊接方法<br>Welding Process | 焊缝长度<br>W. L ( mm ) | 缺陷编号<br>Defect No. | 缺陷性质及大小<br>DNS | 评定意见<br>Judge |
|---|---|---|---|---|---|---|---|---|---|
| 2"-CR-70156-A2BZ-HT45 | W036 | 92 | --- | V | GTAW | 188 | --- | --- | Acc |

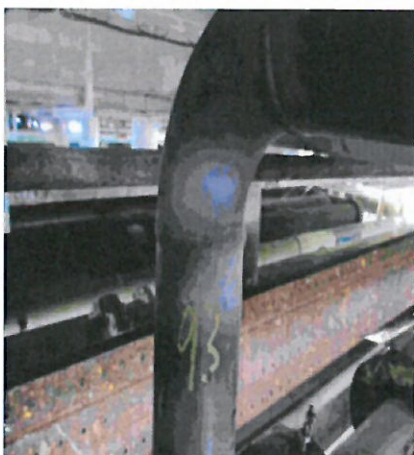
| 工件编号<br>Workpiece No. | 焊工号<br>Welder No. | 焊口号<br>Weld No. | 热处理状态<br>HTS | 坡口形式<br>Groove Form | 焊接方法<br>Welding Process | 焊缝长度<br>W. L ( mm ) | 缺陷编号<br>Defect No. | 缺陷性质及大小<br>DNS | 评定意见<br>Judge |
|---|---|---|---|---|---|---|---|---|---|
| 2"-CR-70156-A2BZ-HT45 | W036 | 93 | --- | V | GTAW | 188 | --- | --- | Acc |

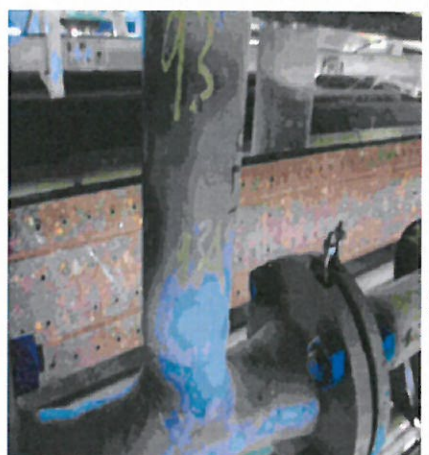
| 工件编号<br>Workpiece No. | 焊工号<br>Welder No. | 焊口号<br>Weld No. | 热处理状态<br>HTS | 坡口形式<br>Groove Form | 焊接方法<br>Welding Process | 焊缝长度<br>W. L ( mm ) | 缺陷编号<br>Defect No. | 缺陷性质及大小<br>DNS | 评定意见<br>Judge |
|---|---|---|---|---|---|---|---|---|---|
| 2"-CR-70156-A2BZ-HT45 | W036 | 93A | --- | V | GTAW | 188 | --- | --- | Acc |

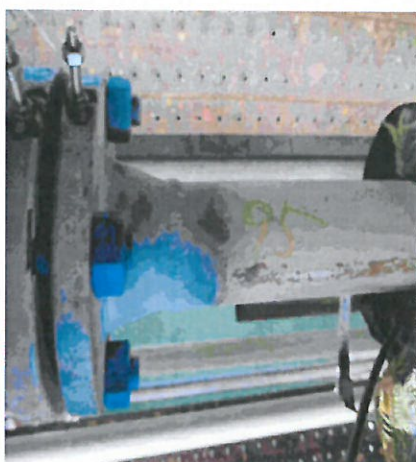
| 工件编号<br>Workpiece No. | 焊工号<br>Welder No. | 焊口号<br>Weld No. | 热处理状态<br>HTS | 坡口形式<br>Groove Form | 焊接方法<br>Welding Process | 焊缝长度<br>W. L ( mm ) | 缺陷编号<br>Defect No. | 缺陷性质及大小<br>DNS | 评定意见<br>Judge |
|---|---|---|---|---|---|---|---|---|---|
| 2"-CR-70156-A2BZ-HT45 | W036 | 95 | --- | V | GTAW | 188 | --- | --- | Acc |

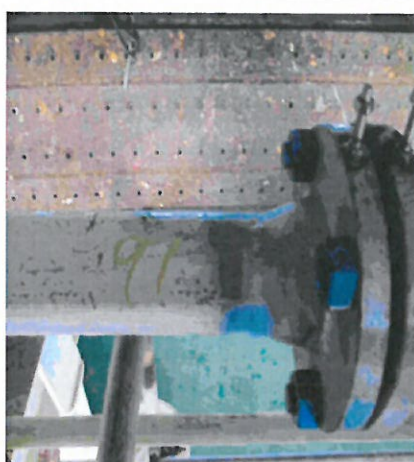
| 工件编号<br>Workpiece No. | 焊工号<br>Welder No. | 焊口号<br>Weld No. | 热处理状态<br>HTS | 坡口形式<br>Groove Form | 焊接方法<br>Welding Process | 焊缝长度<br>W. L ( mm ) | 缺陷编号<br>Defect No. | 缺陷性质及大小<br>DNS | 评定意见<br>Judge |
|---|---|---|---|---|---|---|---|---|---|
| 2"-CR-70156-A2BZ-HT45 | W036 | 97 | --- | V | GTAW | 188 | --- | --- | Acc |

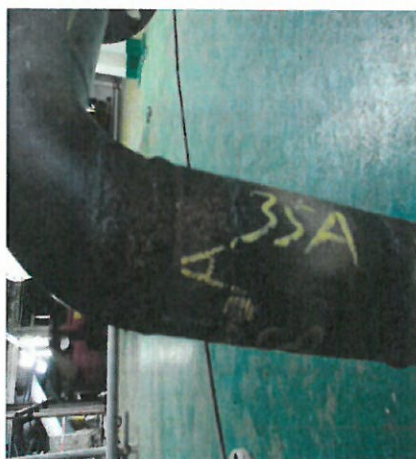
| 工件编号<br>Workpiece No. | 焊工号<br>Welder No. | 焊口号<br>Weld No. | 热处理状态<br>HTS | 坡口形式<br>Groove Form | 焊接方法<br>Welding Process | 焊缝长度<br>W.L. (mm) | 缺陷编号<br>Defect No. | 缺陷性质及大小<br>DNS | 评定意见<br>Judge |
|---|---|---|---|---|---|---|---|---|---|
| 2"-FD-32094-A2BZ | W078 | 35A | -- | V | GTAW | 188 | -- | -- | Acc |
