### NONDESTRUCTIVE TESTING REPORT

HYSY115FPSO Gas Excess Reform Project Pipeline Electrical Instrument

报告编号 Report No. : CJP-WR-094-030-RT001-19-052

## RADIOGRAPHIC INSPECTION REPORT

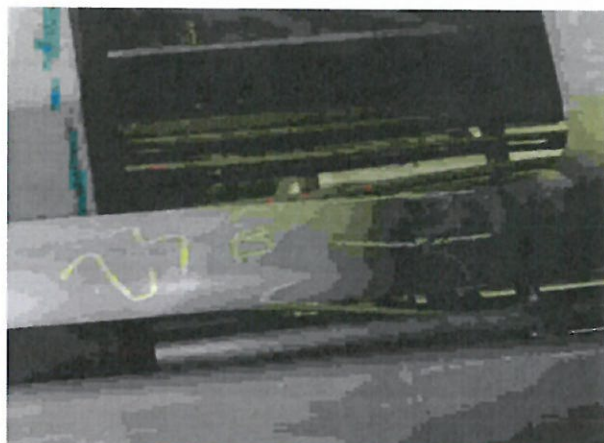
| 序号<br>No. | 工件号<br>Workpiece No. | 焊缝号<br>Weld No. | 焊工号<br>Welder No. | 底片编号<br>Film No. | 焊接方法<br>Welding Process | 焊缝长度<br>W. L(mm) | 直径/厚度<br>Dia/THK (mm) | 缺陷情况<br>Defect Condition(mm) | 意见 Judge | | 返修次数<br>Repair Times | 返修报告<br>Repair Report No. |
|---|---|---|---|---|---|---|---|---|---|---|---|---|
| 1 | 2"-DC-66255-A2BZ-HT45 | 23 | W011 | A | GTAW | 188 | Φ60×5.5 | -- | -- | Acc | -- | -- |
| 2 | 2"-DC-66255-A2BZ-HT45 | 23 | W011 | B | GTAW | 188 | Φ60×5.5 | -- | -- | Acc | -- | -- |
| 3 | 2"-DC-66255-A2BZ-HT45 | 23 | W011 | C | GTAW | 188 | Φ60×5.5 | -- | -- | Acc | -- | -- |

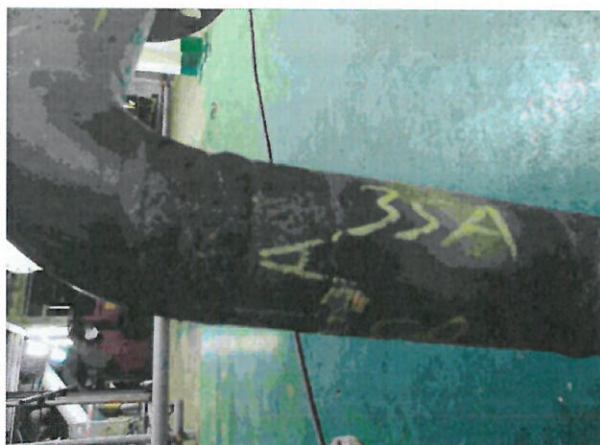
| 序号<br>No. | 工件号<br>Workpiece No. | 焊缝号<br>Weld No. | 焊工号<br>Welder No. | 底片编号<br>Film No. | 焊接方法<br>Welding Process | 焊缝长度<br>W. L(mm) | 直径/厚度<br>Dia/THK (mm) | 缺陷情况<br>Defect Condition(mm) | 意见 Judge | | 返修次数<br>Repair Times | 返修报告<br>Repair Report No. |
|---|---|---|---|---|---|---|---|---|---|---|---|---|
| 4 | 2"-FD-32094-A2BZ | 35A | W078 | A | GTAW | 188 | Φ60×5.5 | -- | -- | Acc | -- | -- |
| 5 | 2"-FD-32094-A2BZ | 35A | W078 | B | GTAW | 188 | Φ60×5.5 | -- | -- | Acc | -- | -- |
| 6 | 2"-FD-32094-A2BZ | 35A | W078 | C | GTAW | 188 | Φ60×5.5 | -- | -- | Acc | -- | -- |

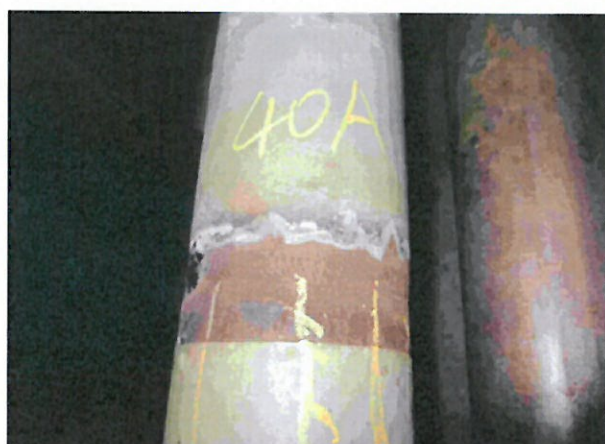
| 序号<br>No. | 工件号<br>Workpiece No. | 焊缝号<br>Weld No. | 焊工号<br>Welder<br>No. | 底片编号<br>Film No. | 焊接方法<br>Welding<br>Process | 焊缝长度<br>W. L (mm) | 直径/厚度<br>Dia/THK<br>(mm) | 缺陷情况<br>Defect Condition (mm) | 意见 Judge | | 返修次数<br>Repair<br>Times | 返修报告<br>Repair Report No. |
|---|---|---|---|---|---|---|---|---|---|---|---|---|
| 28 | 4"-FL-34308-A2BZ-P | 40A | W078 | 0-1 | GTAW | 358 | Φ114×6 | --- | --- | Acc | --- | --- |
| 29 | 4"-FL-34308-A2BZ-P | 40A | W078 | 1-2 | GTAW | 358 | Φ114×6 | --- | --- | Acc | --- | --- |
| 30 | 4"-FL-34308-A2BZ-P | 40A | W078 | 2-3 | GTAW | 358 | Φ114×6 | --- | --- | Acc | --- | --- |
| 31 | 4"-FL-34308-A2BZ-P | 40A | W078 | 3-4 | GTAW | 358 | Φ114×6 | PΦ1×1 | --- | Acc | --- | --- |

| 序号<br>No. | 工件号<br>Workpiece No. | 焊缝号<br>Weld No. | 焊工号<br>Welder No. | 底片编号<br>Film No. | 焊接方法<br>Welding Process | 焊缝长度<br>W.L(mm) | 直径/厚度<br>Dia/THK<br>(mm) | 缺陷情况<br>Defect Condition(mm) | 意见 Judge | | 返修次数<br>Repair Times | 返修报告<br>Repair Report No. |
|---|---|---|---|---|---|---|---|---|---|---|---|---|
| 32 | 4"-FL-34308-A2BZ-P | 40A | W078 | 4-0 | GTAW | 358 | Φ114×6 | -- | -- | Acc | -- | -- |

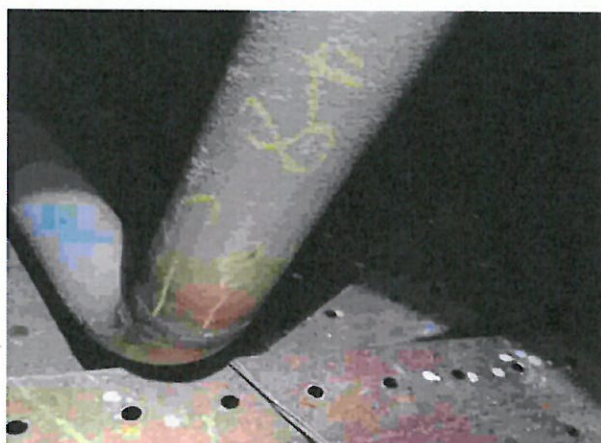
| 序号<br>No. | 工件号<br>Workpiece No. | 焊缝号<br>Weld No. | 焊工号<br>Welder No. | 底片编号<br>Film No. | 焊接方法<br>Welding Process | 焊缝长度<br>W. L(mm) | 直径/厚度<br>Dia/THK (mm) | 缺陷情况<br>Defect Condition(mm) | 意见 Judge | | 返修次数<br>Repair Times | 返修报告<br>Repair Report No. |
|---|---|---|---|---|---|---|---|---|---|---|---|---|
| 7 | 2"-WF-42094-A2BZ | 48 | W011 | A | GTAW | 188 | Φ60×5.5 | PΦ1×1 | -- | Acc | -- | -- |
| 8 | 2"-WF-42094-A2BZ | 48 | W011 | B | GTAW | 188 | Φ60×5.5 | -- | -- | Acc | -- | -- |
| 8 | 2"-WF-42094-A2BZ | 48 | W011 | C | GTAW | 188 | Φ60×5.5 | -- | -- | Acc | -- | -- |

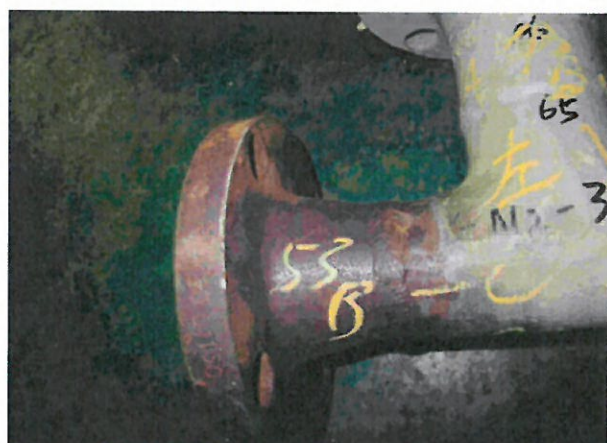
| 序号<br>No. | 工件号<br>Workpiece No. | 焊缝号<br>Weld No. | 焊工号<br>Welder<br>No. | 底片编号<br>Film No. | 焊接方法<br>Welding<br>Process | 焊缝长度<br>W. L (mm) | 直径/厚度<br>Dia/THK<br>(mm) | 缺陷情况<br>Defect Condition (mm) | 意见 Judge | | 返修次数<br>Repair<br>Times | 返修报告<br>Repair Report No. |
|---|---|---|---|---|---|---|---|---|---|---|---|---|
| 13 | 2"-CR-70155-A2BZ-HT45 | 53B | W036 | A | GTAW | 188 | Φ60×5.5 | 弧坑裂纹1mm | --- | Acc | --- | --- |
| 14 | 2"-CR-70155-A2BZ-HT45 | 53B | W036 | B | GTAW | 188 | Φ60×5.5 | --- | --- | Acc | --- | --- |
| 15 | 2"-CR-70155-A2BZ-HT45 | 53B | W036 | C | GTAW | 188 | Φ60×5.5 | --- | --- | Acc | --- | --- |

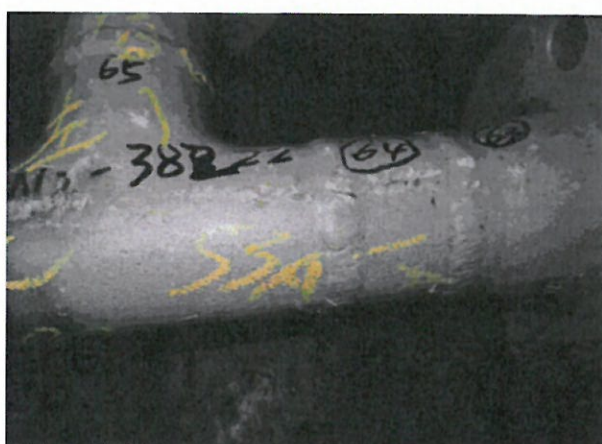
| 序号<br>No. | 工件号<br>Workpiece No. | 焊缝号<br>Weld No. | 焊工号<br>Welder No. | 底片编号<br>Film No. | 焊接方法<br>Welding Process | 焊缝长度<br>W. L(mm) | 直径/厚度<br>Dia/THK (mm) | 缺陷情况<br>Defect Condition(mm) | 意见 Judge | | 返修次数<br>Repair Times | 返修报告<br>Repair Report No. |
|---|---|---|---|---|---|---|---|---|---|---|---|---|
| 10 | 2"-CR-70155-A2BZ-HT45 | 53A | W036 | A | GTAW | 188 | Φ60×5.5 | -- | -- | Acc | -- | -- |
| 11 | 2"-CR-70155-A2BZ-HT45 | 53A | W036 | B | GTAW | 188 | Φ60×5.5 | -- | -- | Acc | -- | -- |

| 序号<br>No. | 工件号<br>Workpiece No. | 焊缝号<br>Weld No. | 焊工号<br>Welder<br>No. | 底片编号<br>Film No. | 焊接方法<br>Welding<br>Process | 焊缝长度<br>W. L (mm) | 直径/厚度<br>Dia/THK<br>(mm) | 缺陷情况<br>Defect Condition (mm) | 意见 Judge | | 返修次数<br>Repair<br>Times | 返修报告<br>Repair Report No. |
|---|---|---|---|---|---|---|---|---|---|---|---|---|
| 12 | 2"-CR-70155-A2BZ-HT45 | 53A | W036 | C | GTAW | 188 | Φ60×5.5 | --- | --- | Acc | --- | --- |

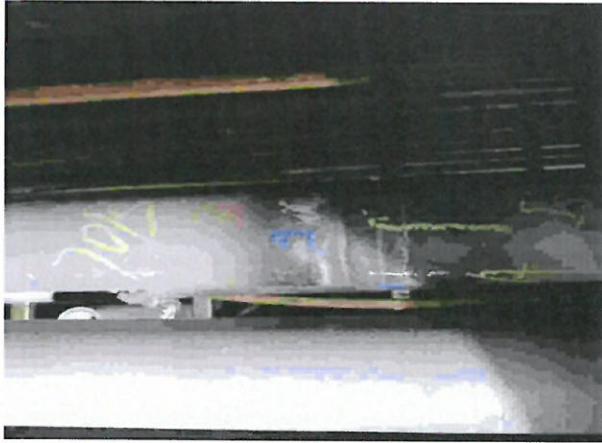
| 序号<br>No. | 工件号<br>Workpiece No. | 焊缝号<br>Weld No. | 焊工号<br>Welder<br>No. | 底片编号<br>Film No. | 焊接方法<br>Welding<br>Process | 焊缝长度<br>W. L (mm) | 直径/厚度<br>Dia/THK<br>(mm) | 缺陷情况<br>Defect Condition (mm) | 意见 Judge | | 返修次数<br>Repair<br>Times | 返修报告<br>Repair Report No. |
|---|---|---|---|---|---|---|---|---|---|---|---|---|
| 16 | 2"-N2-38049-A2BZ | 70B | W011 | A | GTAW | 188 | Φ60×5.5 | --- | --- | Acc | --- | --- |
| 17 | 2"-N2-38049-A2BZ | 70B | W011 | B | GTAW | 188 | Φ60×5.5 | --- | --- | Acc | --- | --- |
| 18 | 2"-N2-38049-A2BZ | 70B | W011 | C | GTAW | 188 | Φ60×5.5 | --- | --- | Acc | --- | --- |

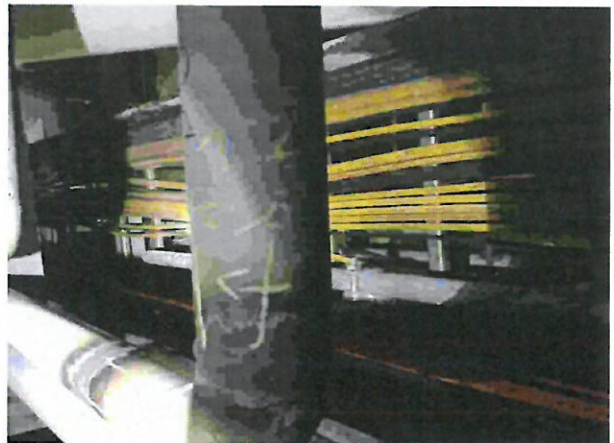
| 序号<br>No. | 工件号<br>Workpiece No. | 焊缝号<br>Weld No. | 焊工号<br>Welder<br>No. | 底片编号<br>Film No. | 焊接方法<br>Welding<br>Process | 焊缝长度<br>W. L (mm) | 直径/厚度<br>Dia/THK<br>(mm) | 缺陷情况<br>Defect Condition (mm) | 意见 Judge | | 返修次数<br>Repair<br>Times | 返修报告<br>Repair Report No. |
|---|---|---|---|---|---|---|---|---|---|---|---|---|
| 19 | 2"-N2-38049-A2BZ | 72 | W011 | A | GTAW | 188 | Φ60×5.5 | --- | --- | Acc | --- | --- |
| 20 | 2"-N2-38049-A2BZ | 72 | W011 | B | GTAW | 188 | Φ60×5.5 | --- | --- | Acc | --- | --- |
| 21 | 2"-N2-38049-A2BZ | 72 | W011 | C | GTAW | 188 | Φ60×5.5 | --- | --- | Acc | --- | --- |

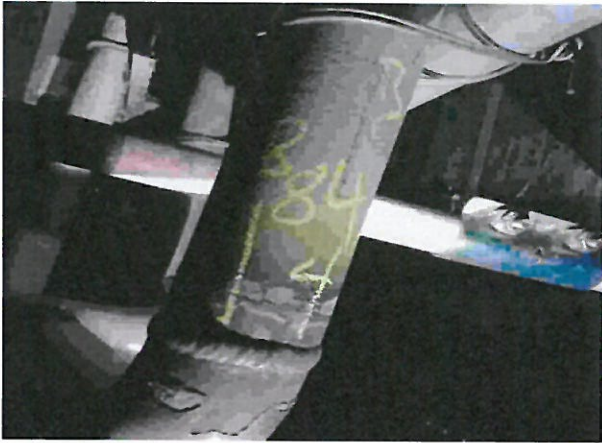
| 序号<br>No. | 工件号<br>Workpiece No. | 焊缝号<br>Weld No. | 焊工号<br>Welder<br>No. | 底片编号<br>Film No. | 焊接方法<br>Welding<br>Process | 焊缝长度<br>W. L (mm) | 直径/厚度<br>Dia/THK<br>(mm) | 缺陷情况<br>Defect Condition (mm) | 意见 Judge | | 返修次数<br>Repair<br>Times | 返修报告<br>Repair Report No. |
|---|---|---|---|---|---|---|---|---|---|---|---|---|
| 22 | 2"-CR-70257-A2BZ-HT45 | 84 | W078 | A | GTAW | 188 | Φ60×5.5 | --- | --- | Acc | --- | --- |
| 23 | 2"-CR-70257-A2BZ-HT45 | 84 | W078 | B | GTAW | 188 | Φ60×5.5 | --- | --- | Acc | --- | --- |
| 24 | 2"-CR-70257-A2BZ-HT45 | 84 | W078 | C | GTAW | 188 | Φ60×5.5 | --- | --- | Acc | --- | --- |

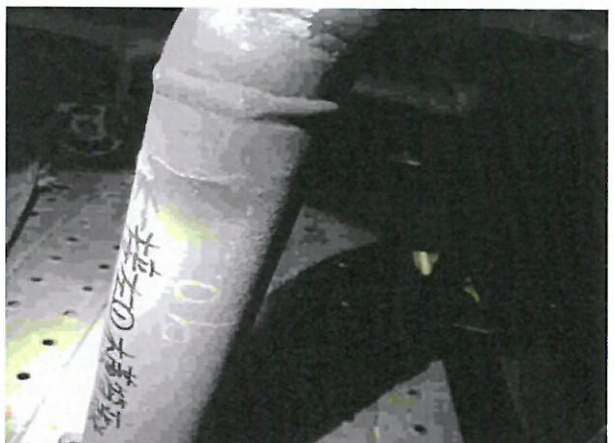
| 序号<br>No. | 工件号<br>Workpiece No. | 焊缝号<br>Weld No. | 焊工号<br>Welder<br>No. | 底片编号<br>Film No. | 焊接方法<br>Welding<br>Process | 焊缝长度<br>W. L (mm) | 直径/厚度<br>Dia/THK<br>(mm) | 缺陷情况<br>Defect Condition (mm) | 意见 Judge | | 返修次数<br>Repair<br>Times | 返修报告<br>Repair Report No. |
|---|---|---|---|---|---|---|---|---|---|---|---|---|
| 25 | 2"-CR-70156-A2BZ-HT45 | 90 | W036 | A | GTAW | 188 | Φ60×5.5 | --- | --- | Acc | --- | --- |
| 26 | 2"-CR-70156-A2BZ-HT45 | 90 | W036 | B | GTAW | 188 | Φ60×5.5 | --- | --- | Acc | --- | --- |
| 27 | 2"-CR-70156-A2BZ-HT45 | 90 | W036 | C | GTAW | 188 | Φ60×5.5 | --- | --- | Acc | --- | --- |

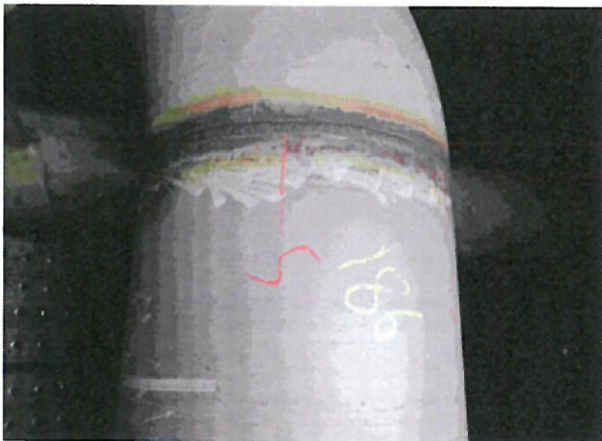
| 序号<br>No. | 工件号<br>Workpiece No. | 焊缝号<br>Weld No. | 焊工号<br>Welder No. | 底片编号<br>Film No. | 焊接方法<br>Welding Process | 焊缝长度<br>W.L(mm) | 直径/厚度<br>Dia/THK<br>(mm) | 缺陷情况<br>Defect Condition(mm) | 意见 Judge | | 返修次数<br>Repair Times | 返修报告<br>Repair Report No. |
|---|---|---|---|---|---|---|---|---|---|---|---|---|
| 33 | 16"-CR-20005-A2BZ-HT45 | 186 | HJ13006 | 0-1 | GTAW | 1275 | Φ406×12.7 | P Φ1×4 | -- | Acc | -- | -- |
| 34 | 16"-CR-20005-A2BZ-HT45 | 186 | HJ13006 | 1-2 | GTAW | 1275 | Φ406×12.7 | -- | -- | Acc | -- | -- |
| 35 | 16"-CR-20005-A2BZ-HT45 | 186 | HJ13006 | 2-3 | GTAW | 1275 | Φ406×12.7 | -- | -- | Acc | -- | -- |
| 36 | 16"-CR-20005-A2BZ-HT45 | 186 | HJ13006 | 3-4 | GTAW | 1275 | Φ406×12.7 | -- | -- | Acc | -- | -- |
| 37 | 16"-CR-20005-A2BZ-HT45 | 186 | HJ13006 | 4-5 | GTAW | 1275 | Φ406×12.7 | P Φ2×2 | -- | Acc | -- | -- |
| 38 | 16"-CR-20005-A2BZ-HT45 | 186 | HJ13006 | 5-0 | GTAW | 1275 | Φ406×12.7 | -- | -- | Acc | -- | -- |

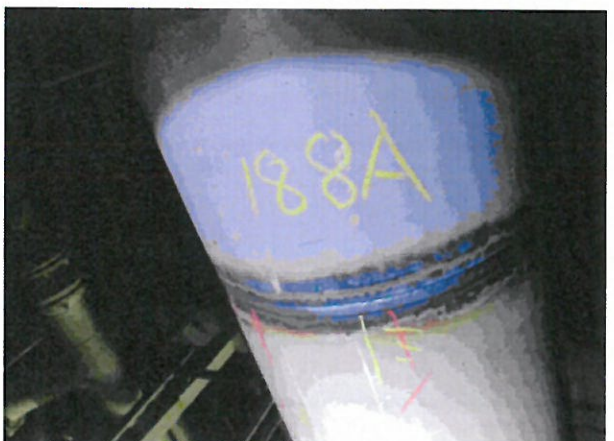
| 序号<br>No. | 工件号<br>Workpiece No. | 焊缝号<br>Weld No. | 焊工号<br>Welder No. | 底片编号<br>Film No. | 焊接方法<br>Welding Process | 焊缝长度<br>W.L(mm) | 直径/厚度<br>Dia/THK<br>(mm) | 缺陷情况<br>Defect Condition(mm) | 意见 Judge | | 返修次数<br>Repair Times | 返修报告<br>Repair Report No. |
|---|---|---|---|---|---|---|---|---|---|---|---|---|
| 39 | 16"-CR-20005-A2BZ-HT45 | 188A | HJ13006 | 0-1 | GTAW | 1275 | Φ406×12.7 | P Φ1×1 | -- | Acc | -- | -- |
| 40 | 16"-CR-20005-A2BZ-HT45 | 188A | HJ13006 | 1-2 | GTAW | 1275 | Φ406×12.7 | P Φ1×1 | -- | Acc | -- | -- |
| 41 | 16"-CR-20005-A2BZ-HT45 | 188A | HJ13006 | 2-3 | GTAW | 1275 | Φ406×12.7 | -- | -- | Acc | -- | -- |
| 42 | 16"-CR-20005-A2BZ-HT45 | 188A | HJ13006 | 3-4 | GTAW | 1275 | Φ406×12.7 | -- | -- | Acc | -- | -- |
| 43 | 16"-CR-20005-A2BZ-HT45 | 188A | HJ13006 | 4-5 | GTAW | 1275 | Φ406×12.7 | P Φ1×2 | -- | Acc | -- | -- |
| 44 | 16"-CR-20005-A2BZ-HT45 | 188A | HJ13006 | 5-0 | GTAW | 1275 | Φ406×12.7 | P Φ1×1 | -- | Acc | -- | -- |
