## 无损检测报告

工程名称 Project Name: HYSY115FPSO 气量超限改造工程

HYSY115FPSO Gas Excess Reform Project Pipeline Electrical Instrument

报告编号 Report No. : CJP-WR-094-030-RT003-19-052

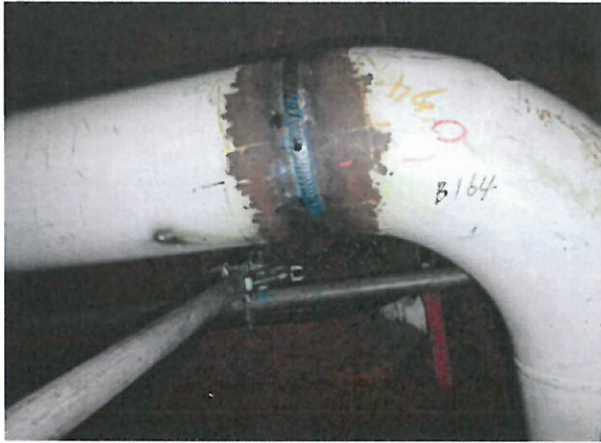
| 序号<br>No. | 工件号<br>Workpiece No. | 焊缝号<br>Weld No. | 焊工号<br>Welder No. | 底片编号<br>Film No. | 焊接方法<br>Welding Process | 焊缝长度<br>W.L(mm) | 直径/厚度<br>Dia/THK (mm) | 缺陷情况<br>Defect Condition(mm) | 意见 Judge | | 返修次数<br>Repair Times | 返修报告<br>Repair Report No. |
|---|---|---|---|---|---|---|---|---|---|---|---|---|
| 17 | X2004-34 | B164 | JW113 | 0-1 | GTAW | 688 | Φ219×8.2 | P Φ1×4 | -- | Acc | -- | -- |
| 18 | X2004-34 | B164 | JW113 | 2-3 | GTAW | 688 | Φ219×8.2 | P Φ1×2 | -- | Acc | -- | -- |
| 19 | X2004-34 | B164 | JW113 | 3-4 | GTAW | 688 | Φ219×8.2 | P Φ1×2 | -- | Acc | -- | -- |
| 20 | X2004-34 | B164 | JW113 | 4-0 | GTAW | 688 | Φ219×8.2 | -- | -- | Acc | -- | -- |

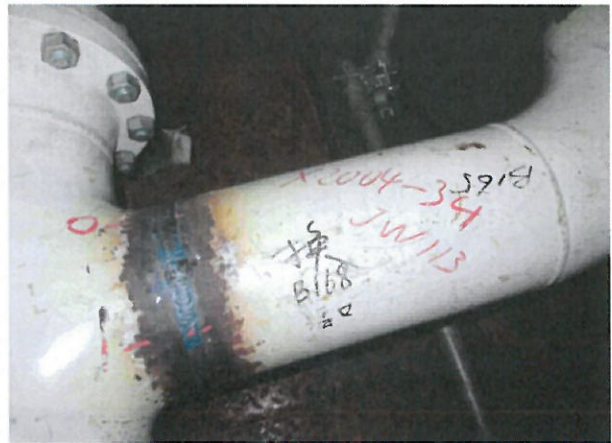
| 序号<br>No. | 工件号<br>Workpiece No. | 焊缝号<br>Weld No. | 焊工号<br>Welder No. | 底片编号<br>Film No. | 焊接方法<br>Welding Process | 焊缝长度<br>W.L(mm) | 直径/厚度<br>Dia/THK (mm) | 缺陷情况<br>Defect Condition(mm) | 意见 Judge | | 返修次数<br>Repair Times | 返修报告<br>Repair Report No. |
|---|---|---|---|---|---|---|---|---|---|---|---|---|
| 21 | X2004-34 | B168 | JW113 | 0-1 | GTAW | 688 | Φ219×8.2 | P Φ2×3 | -- | Acc | -- | -- |
| 22 | X2004-34 | B168 | JW113 | 2-3 | GTAW | 688 | Φ219×8.2 | -- | -- | Acc | -- | -- |
| 23 | X2004-34 | B168 | JW113 | 3-4 | GTAW | 688 | Φ219×8.2 | -- | -- | Acc | -- | -- |

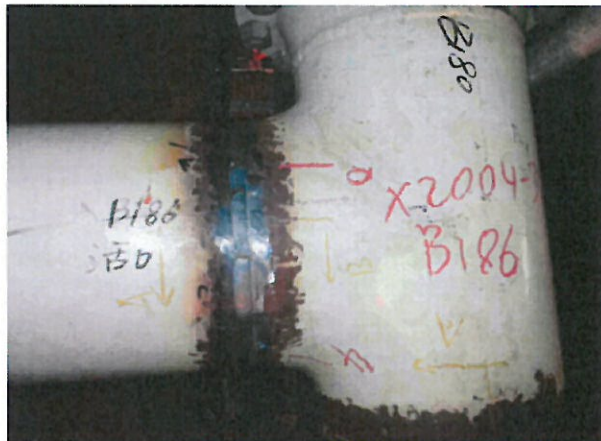
| 序号<br>No. | 工件号<br>Workpiece No. | 焊缝号<br>Weld No. | 焊工号<br>Welder No. | 底片编号<br>Film No. | 焊接方法<br>Welding Process | 焊缝长度<br>W.L(mm) | 直径/厚度<br>Dia/THK (mm) | 缺陷情况<br>Defect Condition(mm) | 意见 Judge | | 返修次数<br>Repair Times | 返修报告<br>Repair Report No. |
|---|---|---|---|---|---|---|---|---|---|---|---|---|
| 39 | X2004-32 | B186 | JW155 | 1-2 | GTAW | 857 | Φ273×9.3 | P Φ1×1 | -- | Acc | -- | -- |
| 40 | X2004-32 | B186 | JW155 | 2-3 | GTAW | 857 | Φ273×9.3 | -- | -- | Acc | -- | -- |
| 41 | X2004-32 | B186 | JW155 | 4-0 | GTAW | 857 | Φ273×9.3 | P Φ1×2 | -- | Acc | -- | -- |

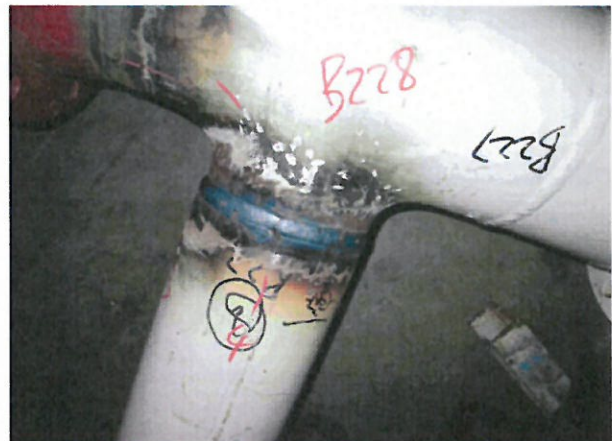
| 检测地点<br>Test Position | HYSY115 | | 放射源<br>Source | X射线机 | | 底片黑度<br>Film Density | 2.0~4.0 | | 显影温度<br>Developing Temperature | 20℃ | | |
|---|---|---|---|---|---|---|---|---|---|---|---|---|
| 1 | X2004-19 | B228 | JW113 | 0-1 | GTAW | 528 | Φ168×7.1 | 夹钨 Φ1×1 | --- | Acc | --- | --- |
| 2 | X2004-19 | B228 | JW113 | 1-2 | GTAW | 528 | Φ168×7.1 | --- | --- | Acc | --- | --- |
| 3 | X2004-19 | B228 | JW113 | 2-3 | GTAW | 528 | Φ168×7.1 | 夹钨 Φ1×1 | --- | Acc | --- | --- |

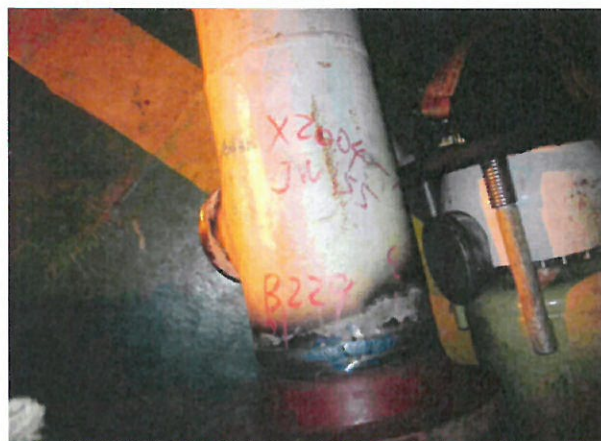
| 序号<br>No. | 工件号<br>Workpiece No. | 焊缝号<br>Weld No. | 焊工号<br>Welder No. | 底片编号<br>Film No. | 焊接方法<br>Welding Process | 焊缝长度<br>W.L(mm) | 直径/厚度<br>Dia/THK (mm) | 缺陷情况<br>Defect Condition(mm) | 意见 Judge | | 返修次数<br>Repair Times | 返修报告<br>Repair Report No. |
|---|---|---|---|---|---|---|---|---|---|---|---|---|
| 24 | X2004-19 | B229 | JW155 | 0-1 | GTAW | 688 | Φ219×8.2 | -- | -- | Acc | -- | -- |
| 25 | X2004-19 | B229 | JW155 | 1-2 | GTAW | 688 | Φ219×8.2 | -- | -- | Acc | -- | -- |
| 26 | X2004-19 | B229 | JW155 | 2-3 | GTAW | 688 | Φ219×8.2 | P Φ1×2 | -- | Acc | -- | -- |
| 27 | X2004-19 | B229 | JW155 | 3-4 | GTAW | 688 | Φ219×8.2 | -- | -- | Acc | -- | -- |
| 28 | X2004-19 | B229 | JW155 | 4-0 | GTAW | 688 | Φ219×8.2 | P Φ1×1 | -- | Acc | -- | -- |

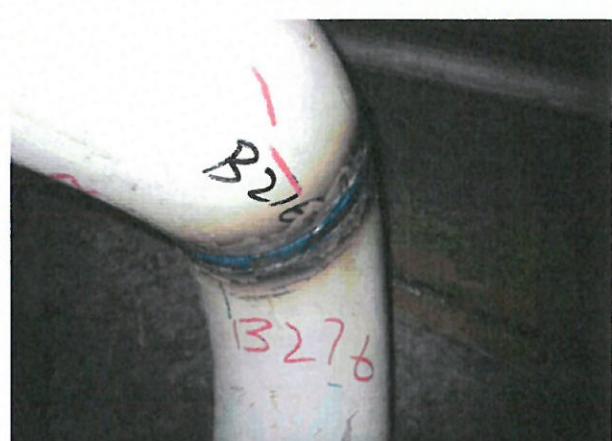
| 检测地点<br>Test Position | HYSY115 | | 放射源<br>Source | X射线机 | | 底片黑度<br>Film Density | 2.0~4.0 | | 显影温度<br>Developing Temperature | 20℃ | | |
|---|---|---|---|---|---|---|---|---|---|---|---|---|
| 4 | X2004-19 | B276 | JW155 | 0-1 | GTAW | 528 | Φ168×7.1 | --- | --- | Acc | --- | --- |
| 5 | X2004-19 | B276 | JW155 | 1-2 | GTAW | 528 | Φ168×7.1 | P Φ2×1 | --- | Acc | --- | --- |
| 6 | X2004-19 | B276 | JW155 | 2-3 | GTAW | 528 | Φ168×7.1 | P Φ2×1 | --- | Acc | --- | --- |
| 7 | X2004-19 | B276 | JW155 | 3-4 | GTAW | 528 | Φ168×7.1 | P Φ1×1 | --- | Acc | --- | --- |
| 8 | X2004-19 | B276 | JW155 | 4-0 | GTAW | 528 | Φ168×7.1 | --- | --- | Acc | --- | --- |

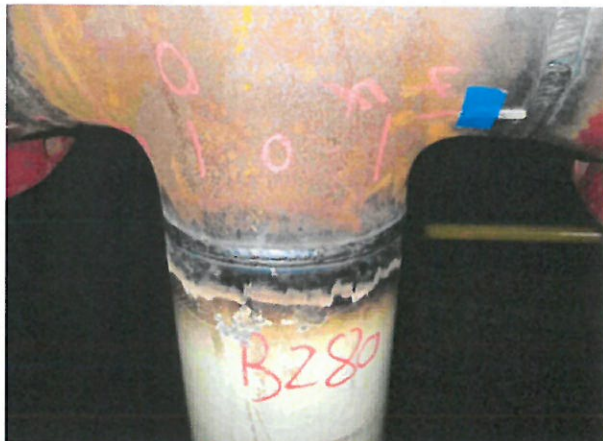
| 检测地点<br>Test Position | HYSY115 | | 放射源<br>Source | X射线机 | | 底片黑度<br>Film Density | 2.0~4.0 | | 显影温度<br>Developing Temperature | 20℃ | | |
|---|---|---|---|---|---|---|---|---|---|---|---|---|
| 8 | X2004-19 | B280 | JW155 | 0-1 | GTAW | 528 | Φ168×7.1 | --- | --- | Acc | --- | --- |
| 10 | X2004-19 | B280 | JW155 | 1-2 | GTAW | 528 | Φ168×7.1 | --- | --- | Acc | --- | --- |

| 序号<br>No. | 工件号<br>Workpiece No. | 焊缝号<br>Weld No. | 焊工号<br>Welder No. | 底片编号<br>Film No. | 焊接方法<br>Welding Process | 焊缝长度<br>W.L(mm) | 直径/厚度<br>Dia/THK (mm) | 缺陷情况<br>Defect Condition(mm) | 意见 Judge | | 返修次数<br>Repair Times | 返修报告<br>Repair Report No. |
|---|---|---|---|---|---|---|---|---|---|---|---|---|
| 11 | X2004-19 | B280 | JW155 | 2-3 | GTAW | 528 | Φ168×7.1 | -- | -- | Acc | -- | -- |
| 12 | X2004-19 | B280 | JW155 | 4-0 | GTAW | 528 | Φ168×7.1 | P Φ2×1 | -- | Acc | -- | -- |

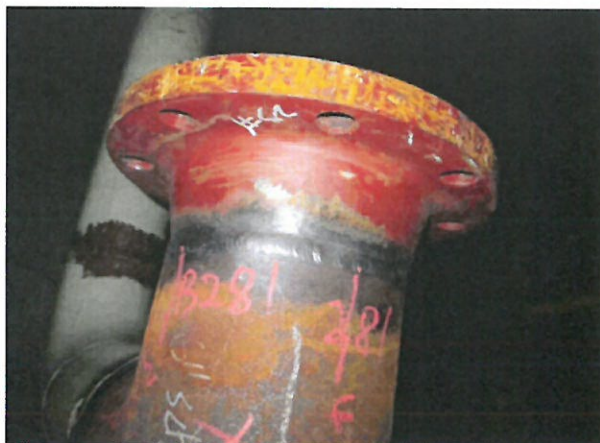
| 序号<br>No. | 工件号<br>Workpiece No. | 焊缝号<br>Weld No. | 焊工号<br>Welder No. | 底片编号<br>Film No. | 焊接方法<br>Welding Process | 焊缝长度<br>W.L(mm) | 直径/厚度<br>Dia/THK (mm) | 缺陷情况<br>Defect Condition(mm) | 意见 Judge | | 返修次数<br>Repair Times | 返修报告<br>Repair Report No. |
|---|---|---|---|---|---|---|---|---|---|---|---|---|
| 13 | X2004-19 | B281 | JW113 | 0-1 | GTAW | 528 | Φ168×7.1 | -- | -- | Acc | -- | -- |
| 14 | X2004-19 | B281 | JW113 | 2-3 | GTAW | 528 | Φ168×7.1 | P Φ2×1 | -- | Acc | -- | -- |

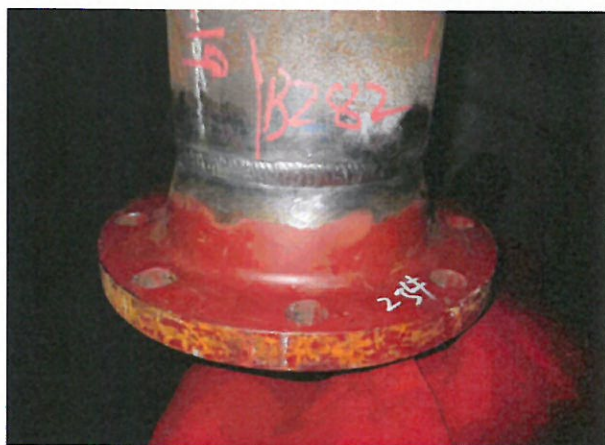
| 序号<br>No. | 工件号<br>Workpiece No. | 焊缝号<br>Weld No. | 焊工号<br>Welder No. | 底片编号<br>Film No. | 焊接方法<br>Welding Process | 焊缝长度<br>W.L(mm) | 直径/厚度<br>Dia/THK (mm) | 缺陷情况<br>Defect Condition(mm) | 意见 Judge | | 返修次数<br>Repair Times | 返修报告<br>Repair Report No. |
|---|---|---|---|---|---|---|---|---|---|---|---|---|
| 15 | X2004-19 | B282 | JW113 | 0-1 | GTAW | 528 | Φ168×7.1 | -- | -- | Acc | -- | -- |
| 16 | X2004-19 | B282 | JW113 | 3-4 | GTAW | 528 | Φ168×7.1 | P Φ2×1 | -- | Acc | -- | -- |
