## 无损检测报告

### NONDESTRUCTIVE TESTING REPORT

工程名称 Project Name: 恩平 118 油轮吊机 A 架裂纹维修 Frame-A  
Crack Maintenance on Enping 118 Tanker

报告编号 Report No. : CJP-WR-051-319-UT001-18-049

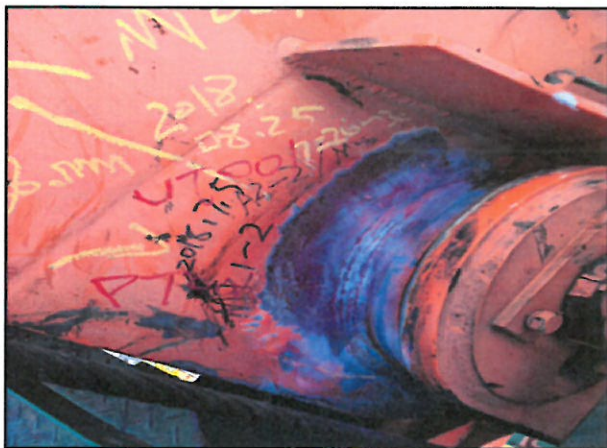
1#吊机 UT001 局部

| 工件编号<br>Workpiece No. | 焊缝号<br>Weld No. | 焊工号<br>Welder No. | 厚度<br>THK (mm) | 焊缝长度<br>W.L (mm) | 探头角度<br>Probe Angle | 缺陷编号<br>Defect No. | 参考点 Reference Point | | | | | 性质<br>Property | 范围<br>Range | 意见<br>Judge | 返修报告号<br>Repair Report No. |
|---|---|---|---|---|---|---|---|---|---|---|---|---|---|---|---|
| IWO/18/08/A263 1#吊机 | UT001局部 | -- | 40mm | 300mm | 59.7° /44.9° | 1 | -- | -- | -- | 26~30 | 68 | -- | -- | Rej | -- |

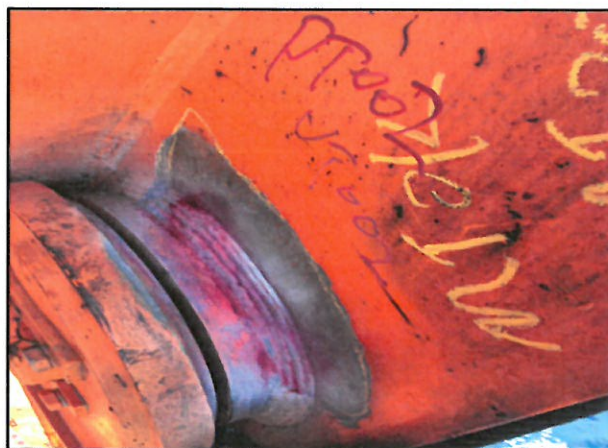
1#吊机 UT002 局部

| 工件编号<br>Workpiece No. | 焊缝号<br>Weld No. | 焊工号<br>Welder No. | 厚度<br>THK (mm) | 焊缝长度<br>W.L (mm) | 探头角度<br>Probe Angle | 缺陷编号<br>Defect No. | 参考点 Reference Point | | | | | 性质<br>Property | 范围<br>Range | 意见<br>Judge | 返修报告号<br>Repair Report No. |
|---|---|---|---|---|---|---|---|---|---|---|---|---|---|---|---|
| IWO/18/08/A263 1#吊机 | UT002局部 | -- | 40mm | 300mm | 59.7° /44.9° | -- | -- | -- | -- | -- | -- | -- | -- | Acc | -- |

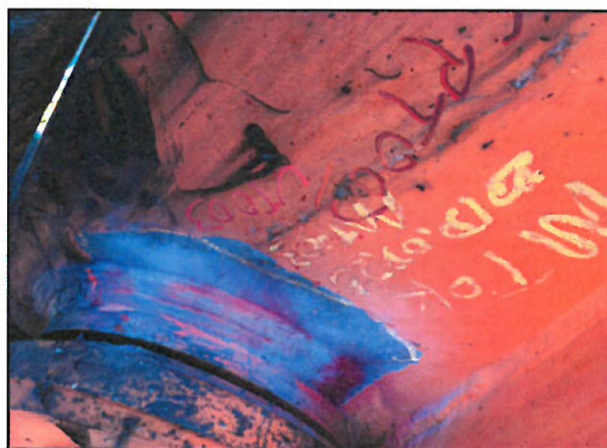
1#吊机 UT003 局部

| 工件编号<br>Workpiece No. | 焊缝号<br>Weld No. | 焊工号<br>Welder No. | 厚度<br>THK (mm) | 焊缝长度<br>W.L (mm) | 探头角度<br>Probe Angle | 缺陷编号<br>Defect No. | 参考点 Reference Point | | | | | 性质<br>Property | 范围<br>Range | 意见<br>Judge | 返修报告号<br>Repair Report No. |
|---|---|---|---|---|---|---|---|---|---|---|---|---|---|---|---|
| IWO/18/08/A263 1#吊机 | UT003局部 | -- | 40mm | 300mm | 59.7° /44.9° | -- | -- | -- | -- | -- | -- | -- | -- | Acc | -- |

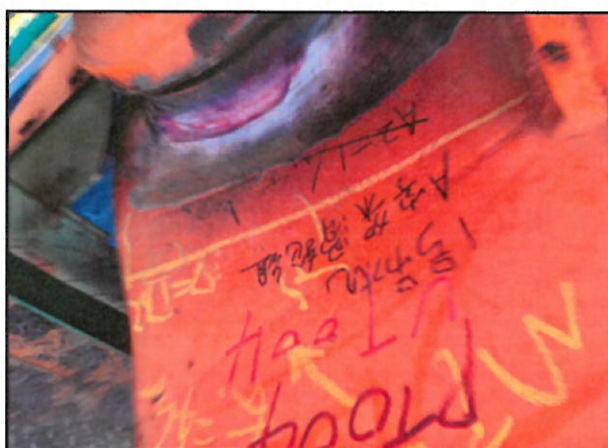
1#吊机 UT004 局部

| 工件编号<br>Workpiece No. | 焊缝号<br>Weld No. | 焊工号<br>Welder No. | 厚度<br>THK (mm) | 焊缝长度<br>W.L (mm) | 探头角度<br>Probe Angle | 缺陷编号<br>Defect No. | 参考点 Reference Point | | | | | 性质<br>Property | 范围<br>Range | 意见<br>Judge | 返修报告号<br>Repair Report No. |
|---|---|---|---|---|---|---|---|---|---|---|---|---|---|---|---|
| IWO/18/08/A263 1#吊机 | UT004局部 | -- | 40mm | 300mm | 59.7° /44.9° | 1 | -- | -- | -- | 16~19 | 46 | -- | -- | Rej | -- |

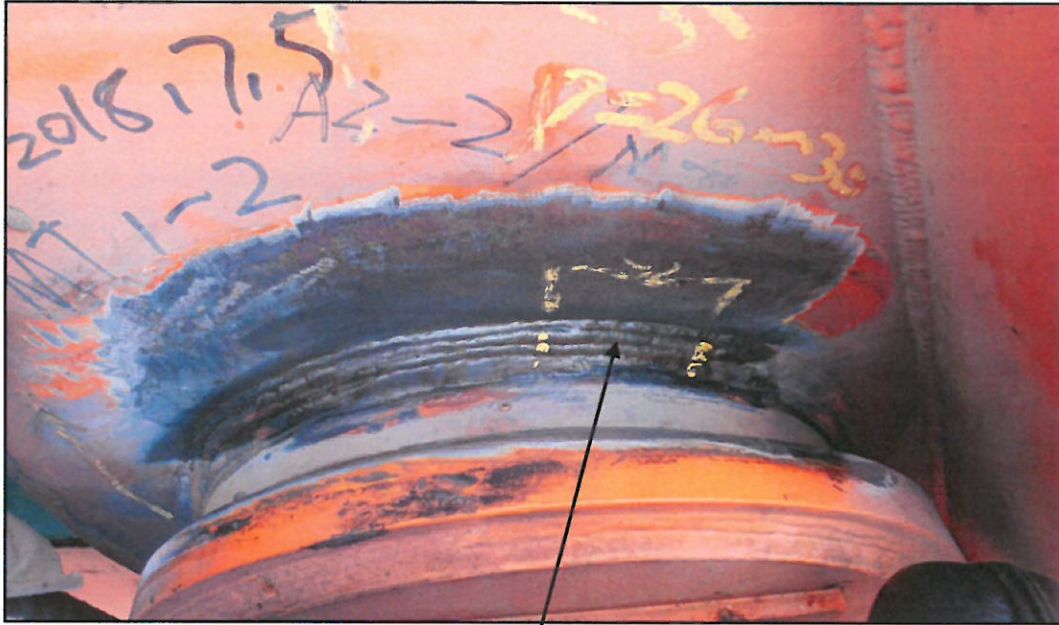
1#吊机 UT001 缺陷位置在焊缝中心偏上方位置, D=26~30mm L=68mm

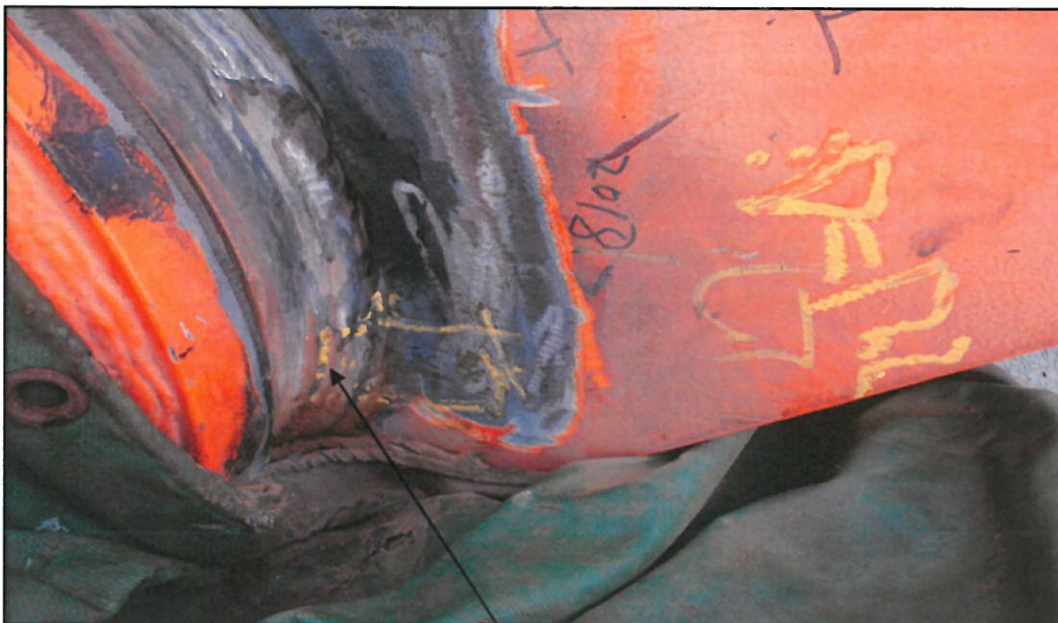
1#吊机 UT004 缺陷位置在焊缝中心位置, D=16~19mm L=46mm

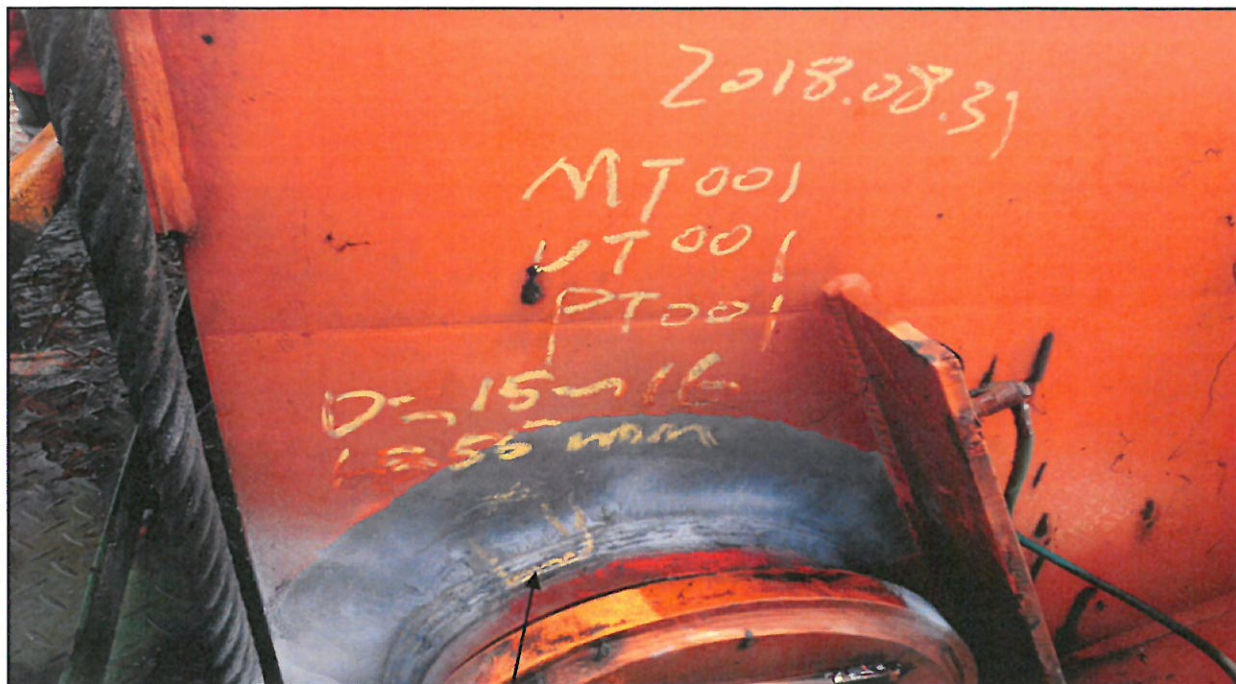
2#UT001 缺陷位置在焊缝中心偏下方位置, D=15~16mm L=55mm
