## 无损检测报告

工程名称 Project Name: 维修 HZ323 平台 1 台电消防泵 One Electric Fire  
Pump Maintenance on HZ323 Platform

报告编号 Report No. : CJP-WR-051-331-PT001-18-074

## LIQUID PENETRANT INSPECTION REPORT

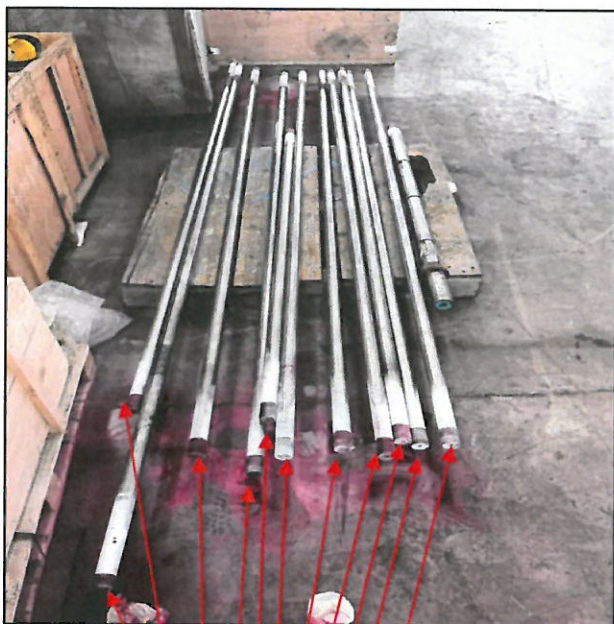
传动轴轴头丝扣 11 根

| 检测地点<br>Testing Position | 太平洋车间<br>QPOC Workshop | 执行标准<br>Executive Standard | | NB/T47013.5-2015 | 清洗剂<br>Cleanser | | DPT-5 | 渗透温度(℃)<br>Penetration Temperature | 20℃ |
|---|---|---|---|---|---|---|---|---|---|
| 传动轴轴头丝扣11根 | -- | -- | -- | -- | -- | -- | -- | -- | I级 合格 |

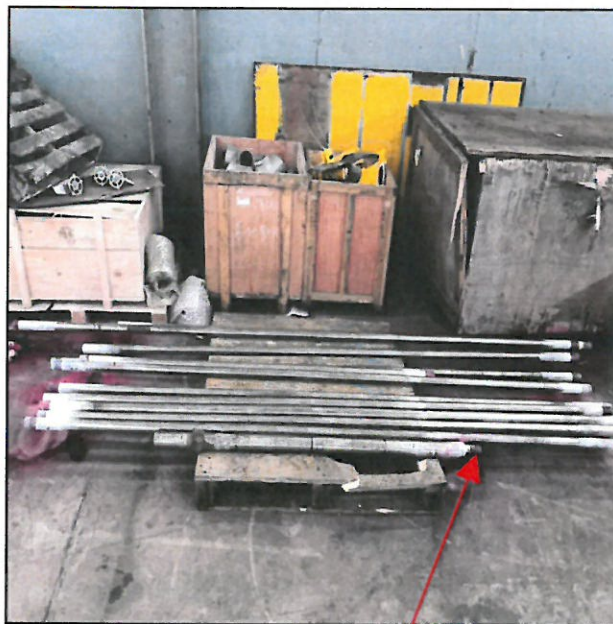
泵轴轴头丝扣 1 根

| 检测地点<br>Testing Position | 太平洋车间<br>QPOC Workshop | 执行标准<br>Executive Standard | | NB/T47013.5-2015 | 清洗剂<br>Cleanser | | DPT-5 | 渗透温度(℃)<br>Penetration Temperature | 20℃ |
|---|---|---|---|---|---|---|---|---|---|
| 泵轴轴头丝扣1根 | -- | -- | -- | -- | -- | -- | -- | -- | I级 合格 |
