## 无损检测报告

### NONDESTRUCTIVE TESTING REPORT

Riser Connector Repair on NH5

报告编号 Report No. : CJP-WR-083-137-MT001-18-050

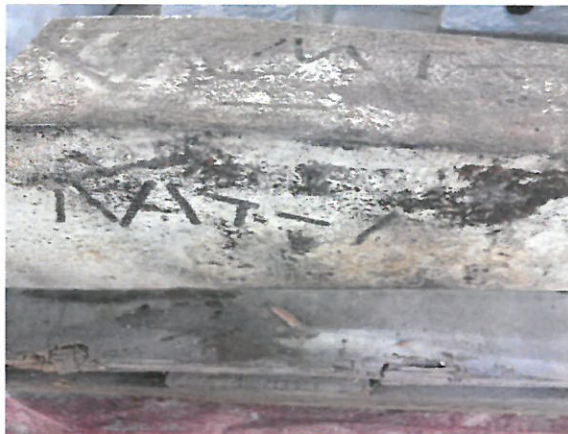
| MT-1 | -- | -- | -- | -- | -- | -- | -- | -- | Acc |

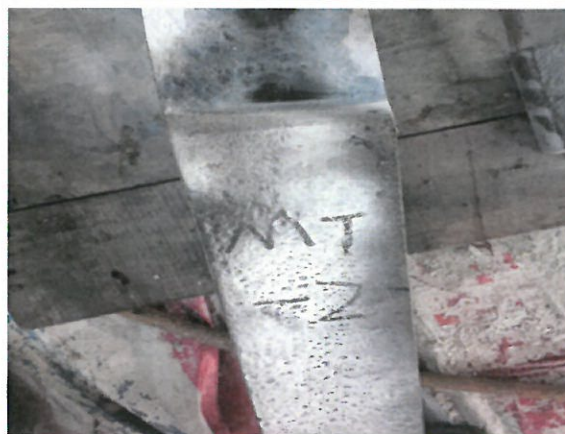
| MT-2 | -- | -- | -- | -- | -- | -- | -- | -- | Acc |

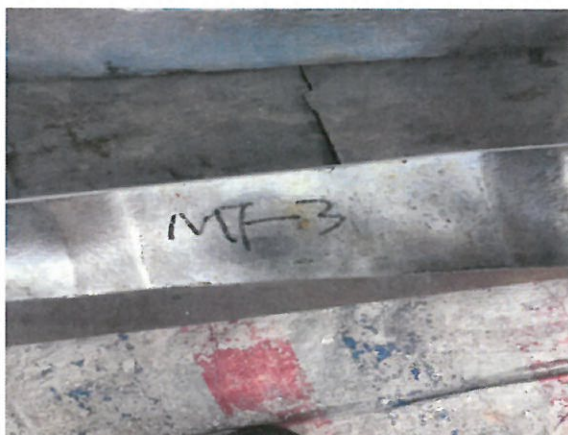
| MT-3 | -- | -- | -- | -- | -- | -- | -- | -- | Acc |

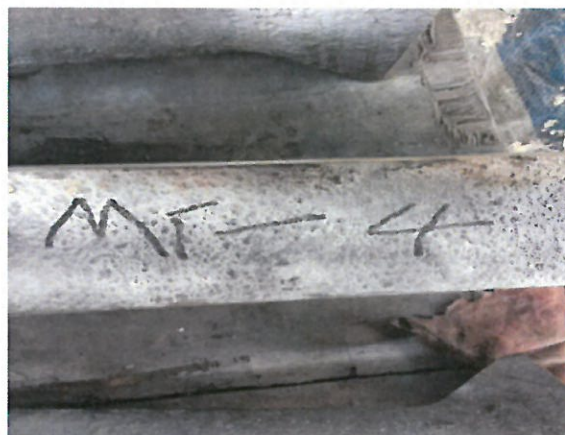
| MT-4 | -- | -- | -- | -- | -- | -- | -- | -- | Acc |

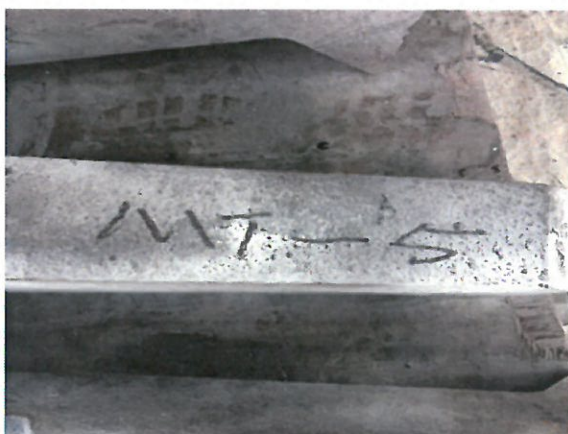
| MT-5 | -- | -- | -- | -- | -- | -- | -- | -- | Acc |

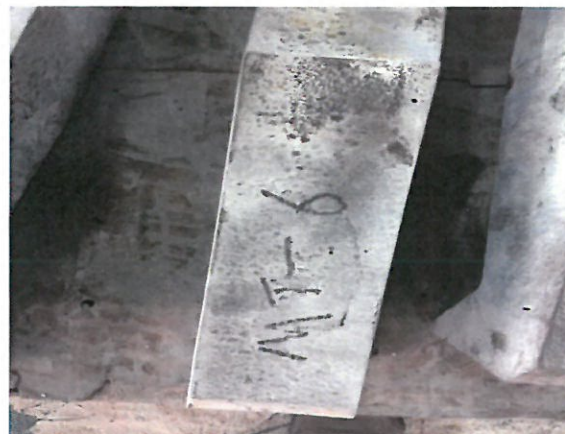
| MT-6 | -- | -- | -- | -- | -- | -- | -- | -- | Acc |

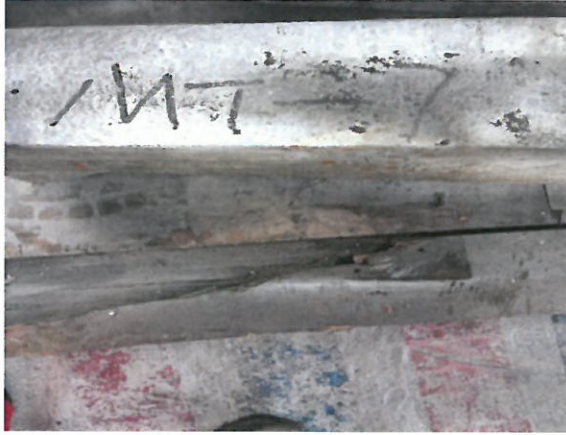
| MT-7 | -- | -- | -- | -- | -- | -- | -- | -- | Acc |

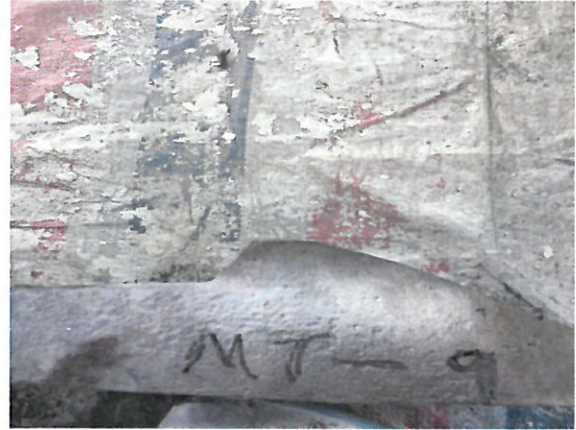
| MT-9 | -- | -- | -- | -- | -- | -- | -- | -- | Acc |

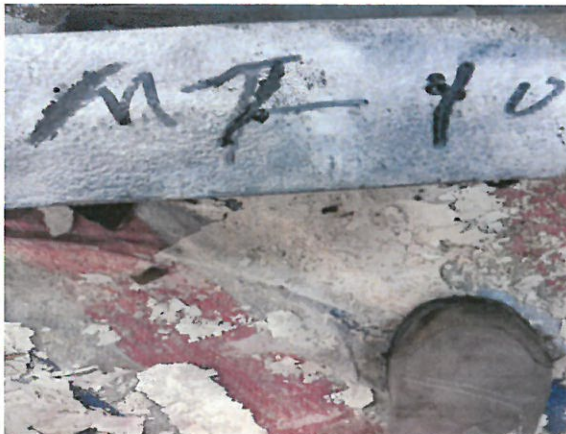
| MT-10 | -- | -- | -- | -- | -- | -- | -- | -- | Acc |

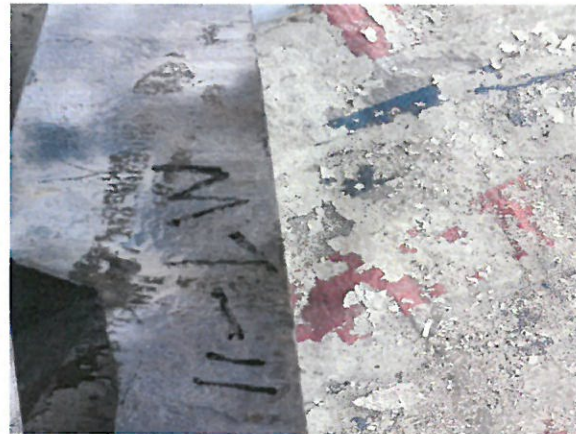
| MT-11 | -- | -- | -- | -- | -- | -- | -- | -- | Acc |

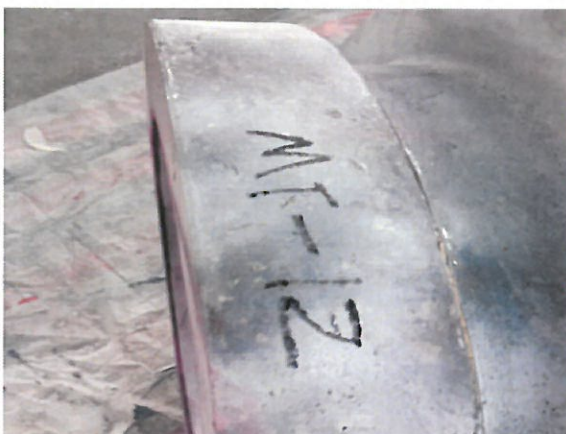
| MT-12 | -- | -- | -- | -- | -- | -- | -- | -- | Acc |

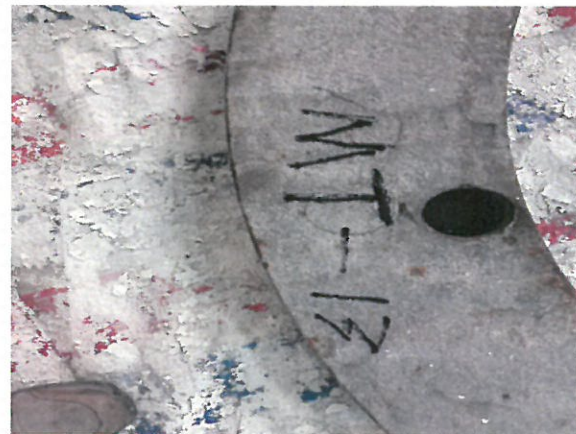
| MT-13 | -- | -- | -- | -- | -- | -- | -- | -- | Acc |

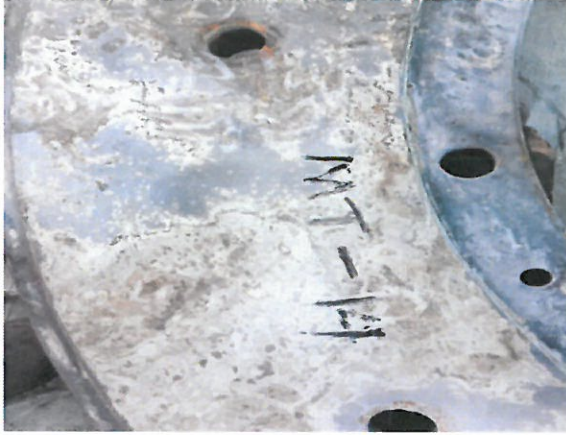
| 工件编号<br>Workpiece No. | 焊工号<br>Welder No. | 焊口号<br>Weld No. | 热处理状态<br>HTS | 坡口形式<br>Groove Form | 焊接方法<br>Welding Process | 焊缝长度<br>W.L( mm ) | 缺陷编号<br>Defect No. | 缺陷性质及大小<br>DNS | 评定意见<br>Judge |
|---|---|---|---|---|---|---|---|---|---|
| MT-14 | -- | -- | -- | -- | -- | -- | -- | -- | Acc |

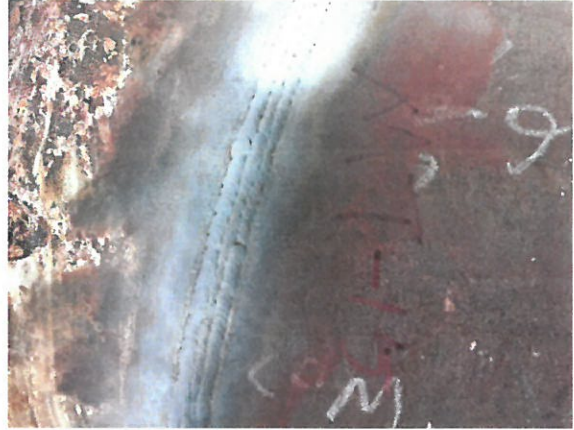
| 工件编号<br>Workpiece No. | 焊工号<br>Welder No. | 焊口号<br>Weld No. | 热处理状态<br>HTS | 坡口形式<br>Groove Form | 焊接方法<br>Welding Process | 焊缝长度<br>W.L( mm ) | 缺陷编号<br>Defect No. | 缺陷性质及大小<br>DNS | 评定意见<br>Judge |
|---|---|---|---|---|---|---|---|---|---|
| MT-15 | -- | -- | -- | -- | -- | -- | -- | -- | Acc |

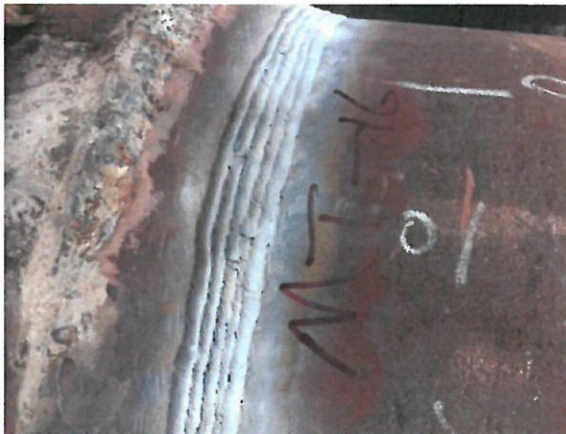
| 工件编号<br>Workpiece No. | 焊工号<br>Welder No. | 焊口号<br>Weld No. | 热处理状态<br>HTS | 坡口形式<br>Groove Form | 焊接方法<br>Welding Process | 焊缝长度<br>W.L( mm ) | 缺陷编号<br>Defect No. | 缺陷性质及大小<br>DNS | 评定意见<br>Judge |
|---|---|---|---|---|---|---|---|---|---|
| MT-16 | -- | -- | -- | -- | -- | -- | -- | -- | Acc |

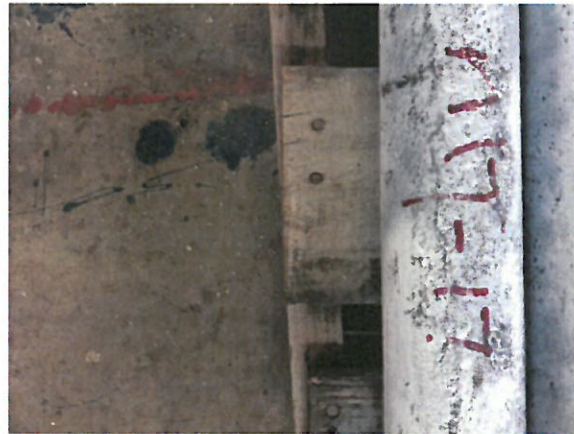
| 工件编号<br>Workpiece No. | 焊工号<br>Welder No. | 焊口号<br>Weld No. | 热处理状态<br>HTS | 坡口形式<br>Groove Form | 焊接方法<br>Welding Process | 焊缝长度<br>W.L( mm ) | 缺陷编号<br>Defect No. | 缺陷性质及大小<br>DNS | 评定意见<br>Judge |
|---|---|---|---|---|---|---|---|---|---|
| MT-17 | -- | -- | -- | -- | -- | -- | -- | -- | Acc |

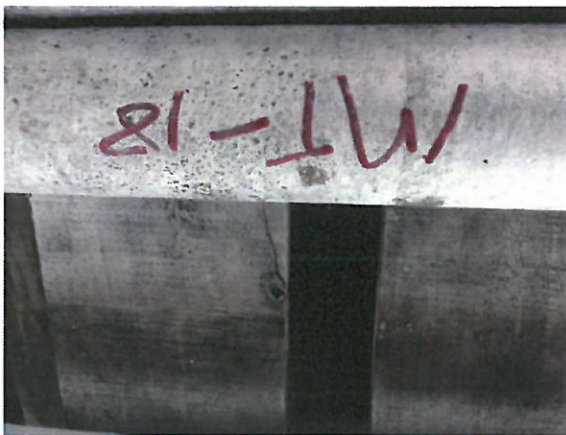
| 工件编号<br>Workpiece No. | 焊工号<br>Welder No. | 焊口号<br>Weld No. | 热处理状态<br>HTS | 坡口形式<br>Groove Form | 焊接方法<br>Welding Process | 焊缝长度<br>W.L( mm ) | 缺陷编号<br>Defect No. | 缺陷性质及大小<br>DNS | 评定意见<br>Judge |
|---|---|---|---|---|---|---|---|---|---|
| MT-18 | -- | -- | -- | -- | -- | -- | -- | -- | Acc |

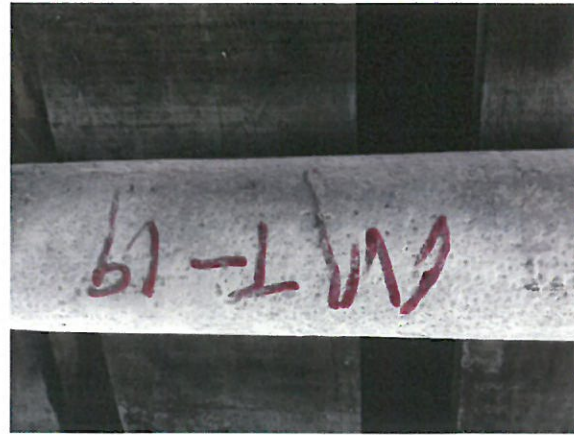
| 工件编号<br>Workpiece No. | 焊工号<br>Welder No. | 焊口号<br>Weld No. | 热处理状态<br>HTS | 坡口形式<br>Groove Form | 焊接方法<br>Welding Process | 焊缝长度<br>W.L( mm ) | 缺陷编号<br>Defect No. | 缺陷性质及大小<br>DNS | 评定意见<br>Judge |
|---|---|---|---|---|---|---|---|---|---|
| MT-19 | -- | -- | -- | -- | -- | -- | -- | -- | Acc |

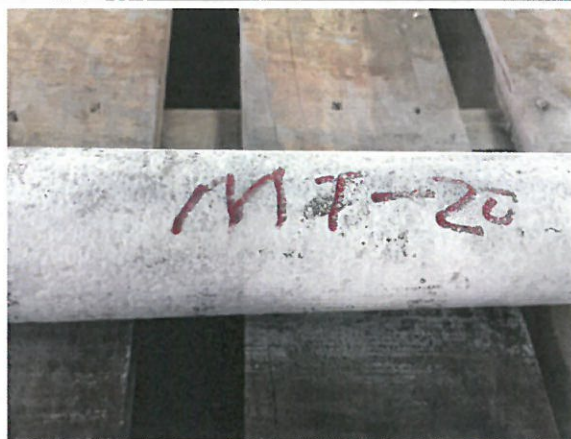
| 工件编号<br>Workpiece No. | 焊工号<br>Welder No. | 焊口号<br>Weld No. | 热处理状态<br>HTS | 坡口形式<br>Groove Form | 焊接方法<br>Welding Process | 焊缝长度<br>W.L( mm ) | 缺陷编号<br>Defect No. | 缺陷性质及大小<br>DNS | 评定意见<br>Judge |
|---|---|---|---|---|---|---|---|---|---|
| MT-20 | -- | -- | -- | -- | -- | -- | -- | -- | Acc |

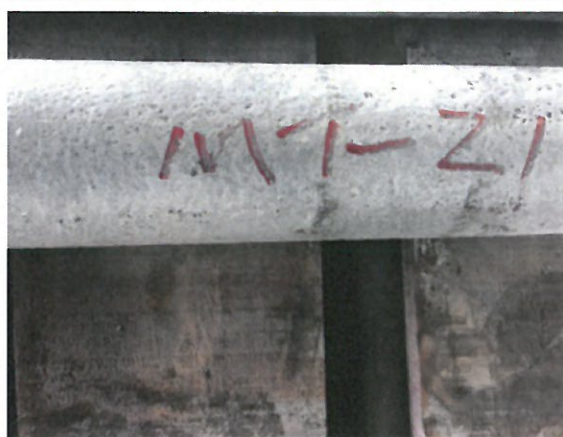
| 工件编号<br>Workpiece No. | 焊工号<br>Welder No. | 焊口号<br>Weld No. | 热处理状态<br>HTS | 坡口形式<br>Groove Form | 焊接方法<br>Welding Process | 焊缝长度<br>W.L( mm ) | 缺陷编号<br>Defect No. | 缺陷性质及大小<br>DNS | 评定意见<br>Judge |
|---|---|---|---|---|---|---|---|---|---|
| MT-21 | -- | -- | -- | -- | -- | -- | -- | -- | Acc |

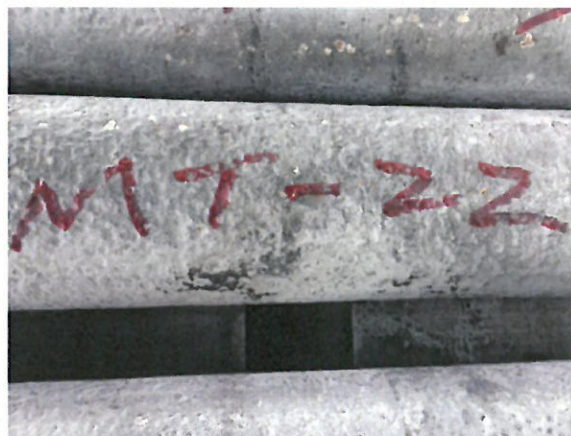
| 工件编号<br>Workpiece No. | 焊工号<br>Welder No. | 焊口号<br>Weld No. | 热处理状态<br>HTS | 坡口形式<br>Groove Form | 焊接方法<br>Welding Process | 焊缝长度<br>W.L( mm ) | 缺陷编号<br>Defect No. | 缺陷性质及大小<br>DNS | 评定意见<br>Judge |
|---|---|---|---|---|---|---|---|---|---|
| MT-22 | -- | -- | -- | -- | -- | -- | -- | -- | Acc |

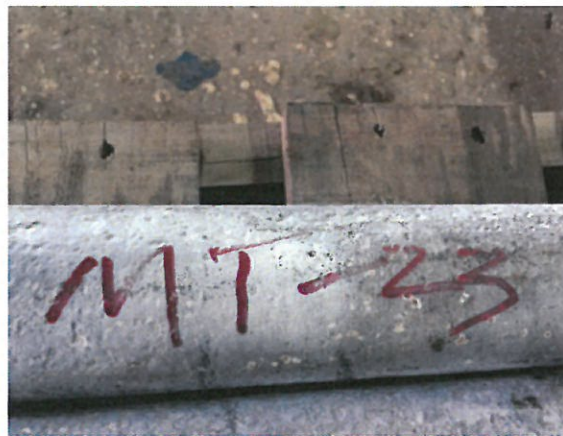
| 工件编号<br>Workpiece No. | 焊工号<br>Welder No. | 焊口号<br>Weld No. | 热处理状态<br>HTS | 坡口形式<br>Groove Form | 焊接方法<br>Welding Process | 焊缝长度<br>W.L( mm ) | 缺陷编号<br>Defect No. | 缺陷性质及大小<br>DNS | 评定意见<br>Judge |
|---|---|---|---|---|---|---|---|---|---|
| MT-23 | -- | -- | -- | -- | -- | -- | -- | -- | Acc |

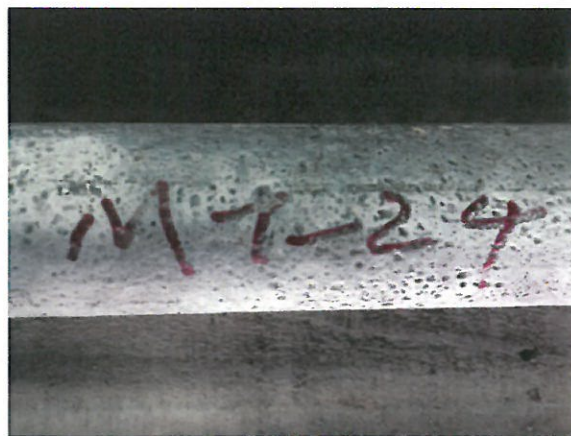
| 工件编号<br>Workpiece No. | 焊工号<br>Welder No. | 焊口号<br>Weld No. | 热处理状态<br>HTS | 坡口形式<br>Groove Form | 焊接方法<br>Welding Process | 焊缝长度<br>W.L( mm ) | 缺陷编号<br>Defect No. | 缺陷性质及大小<br>DNS | 评定意见<br>Judge |
|---|---|---|---|---|---|---|---|---|---|
| MT-24 | -- | -- | -- | -- | -- | -- | -- | -- | Acc |

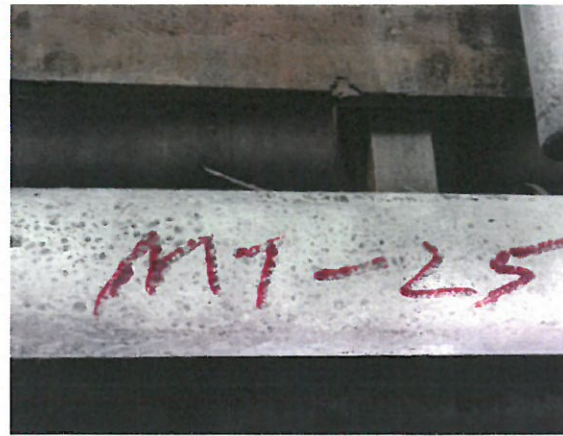
| 工件编号<br>Workpiece No. | 焊工号<br>Welder No. | 焊口号<br>Weld No. | 热处理状态<br>HTS | 坡口形式<br>Groove Form | 焊接方法<br>Welding Process | 焊缝长度<br>W.L( mm ) | 缺陷编号<br>Defect No. | 缺陷性质及大小<br>DNS | 评定意见<br>Judge |
|---|---|---|---|---|---|---|---|---|---|
| MT-25 | -- | -- | -- | -- | -- | -- | -- | -- | Acc |

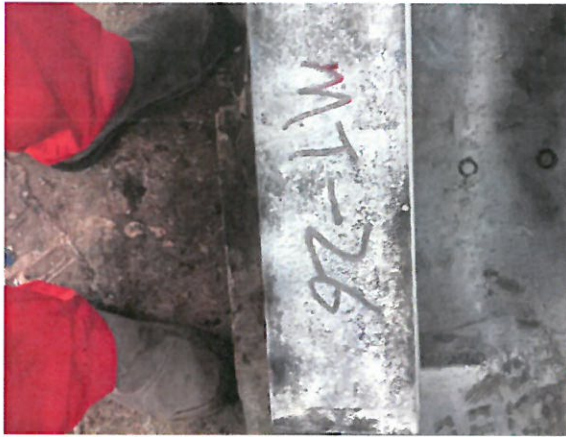
| 工件编号<br>Workpiece No. | 焊工号<br>Welder No. | 焊口号<br>Weld No. | 热处理状态<br>HTS | 坡口形式<br>Groove Form | 焊接方法<br>Welding Process | 焊缝长度<br>W.L( mm ) | 缺陷编号<br>Defect No. | 缺陷性质及大小<br>DNS | 评定意见<br>Judge |
|---|---|---|---|---|---|---|---|---|---|
| MT-26 | -- | -- | -- | -- | -- | -- | -- | -- | Acc |

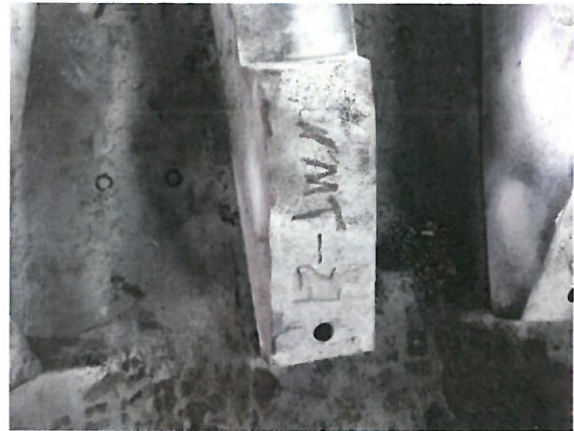
| 工件编号<br>Workpiece No. | 焊工号<br>Welder No. | 焊口号<br>Weld No. | 热处理状态<br>HTS | 坡口形式<br>Groove Form | 焊接方法<br>Welding Process | 焊缝长度<br>W.L( mm ) | 缺陷编号<br>Defect No. | 缺陷性质及大小<br>DNS | 评定意见<br>Judge |
|---|---|---|---|---|---|---|---|---|---|
| MT-27 | -- | -- | -- | -- | -- | -- | -- | -- | Acc |

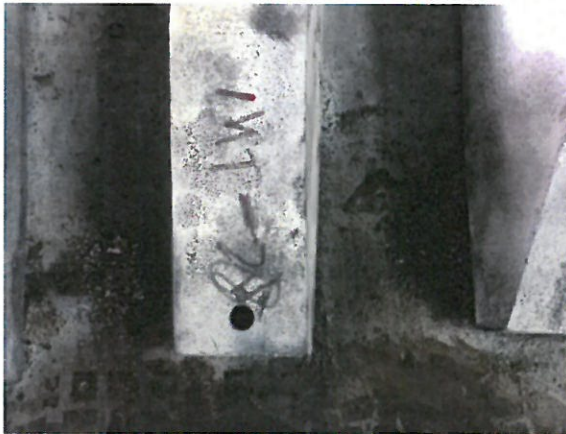
| 工件编号<br>Workpiece No. | 焊工号<br>Welder No. | 焊口号<br>Weld No. | 热处理状态<br>HTS | 坡口形式<br>Groove Form | 焊接方法<br>Welding Process | 焊缝长度<br>W.L( mm ) | 缺陷编号<br>Defect No. | 缺陷性质及大小<br>DNS | 评定意见<br>Judge |
|---|---|---|---|---|---|---|---|---|---|
| MT-28 | -- | -- | -- | -- | -- | -- | -- | -- | Acc |

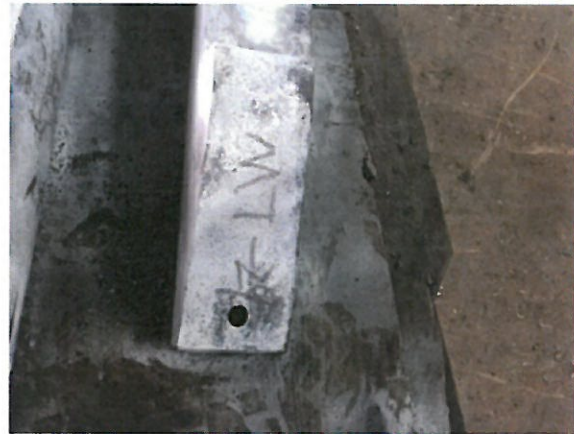
| 工件编号<br>Workpiece No. | 焊工号<br>Welder No. | 焊口号<br>Weld No. | 热处理状态<br>HTS | 坡口形式<br>Groove Form | 焊接方法<br>Welding Process | 焊缝长度<br>W.L( mm ) | 缺陷编号<br>Defect No. | 缺陷性质及大小<br>DNS | 评定意见<br>Judge |
|---|---|---|---|---|---|---|---|---|---|
| MT-29 | -- | -- | -- | -- | -- | -- | -- | -- | Acc |

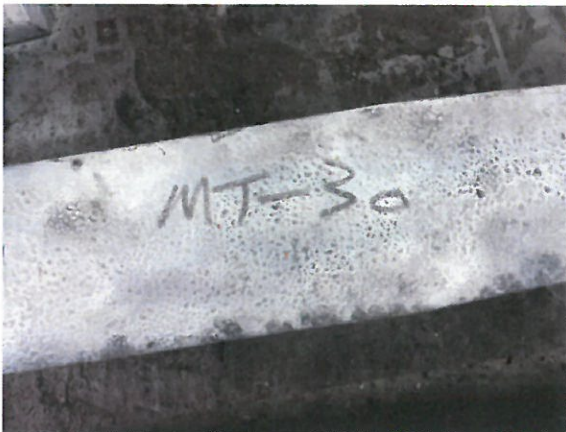
| 工件编号<br>Workpiece No. | 焊工号<br>Welder No. | 焊口号<br>Weld No. | 热处理状态<br>HTS | 坡口形式<br>Groove Form | 焊接方法<br>Welding Process | 焊缝长度<br>W.L( mm ) | 缺陷编号<br>Defect No. | 缺陷性质及大小<br>DNS | 评定意见<br>Judge |
|---|---|---|---|---|---|---|---|---|---|
| MT-30 | -- | -- | -- | -- | -- | -- | -- | -- | Acc |

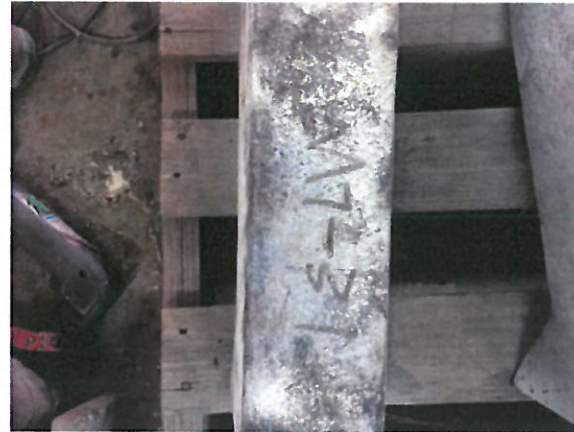
| 工件编号<br>Workpiece No. | 焊工号<br>Welder No. | 焊口号<br>Weld No. | 热处理状态<br>HTS | 坡口形式<br>Groove Form | 焊接方法<br>Welding Process | 焊缝长度<br>W.L( mm ) | 缺陷编号<br>Defect No. | 缺陷性质及大小<br>DNS | 评定意见<br>Judge |
|---|---|---|---|---|---|---|---|---|---|
| MT-31 | -- | -- | -- | -- | -- | -- | -- | -- | Acc |

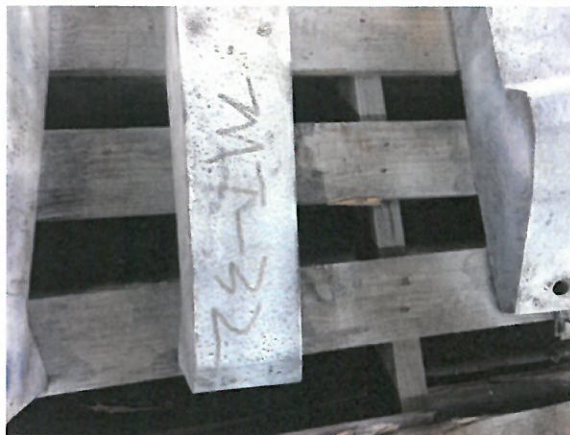
| 工件编号<br>Workpiece No. | 焊工号<br>Welder No. | 焊口号<br>Weld No. | 热处理状态<br>HTS | 坡口形式<br>Groove Form | 焊接方法<br>Welding Process | 焊缝长度<br>W.L( mm ) | 缺陷编号<br>Defect No. | 缺陷性质及大小<br>DNS | 评定意见<br>Judge |
|---|---|---|---|---|---|---|---|---|---|
| MT-32 | -- | -- | -- | -- | -- | -- | -- | -- | Acc |

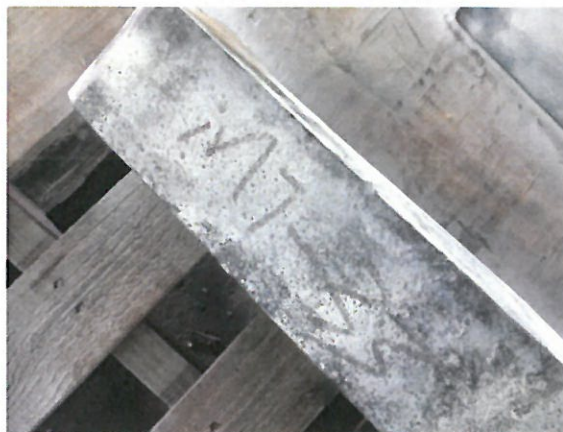
| 工件编号<br>Workpiece No. | 焊工号<br>Welder No. | 焊口号<br>Weld No. | 热处理状态<br>HTS | 坡口形式<br>Groove Form | 焊接方法<br>Welding Process | 焊缝长度<br>W.L( mm ) | 缺陷编号<br>Defect No. | 缺陷性质及大小<br>DNS | 评定意见<br>Judge |
|---|---|---|---|---|---|---|---|---|---|
| MT-33 | -- | -- | -- | -- | -- | -- | -- | -- | Acc |
