### NONDESTRUCTIVE TESTING REPORT

Riser Connector Repair on NH5

报告编号 Report No. : CJP-WR-083-137-PT001-18-050

液体渗透检测报告  
LIQUID PENETRANT INSPECTION REPORT

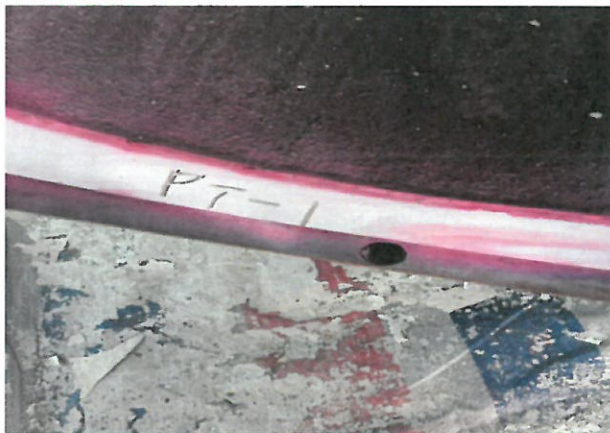
| PT-1 | -- | -- | -- | -- | -- | -- | -- | -- | Acc |

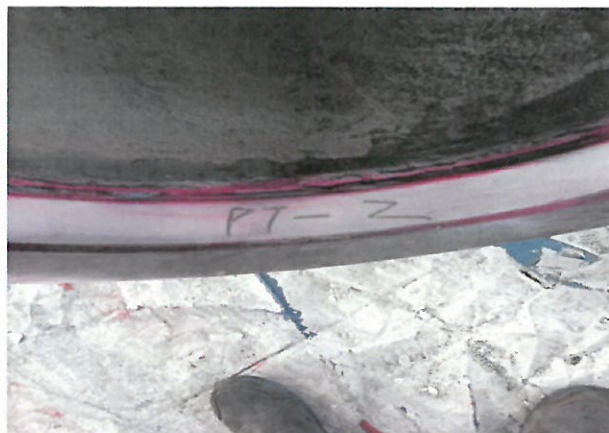
| PT-2 | -- | -- | -- | -- | -- | -- | -- | -- | Acc |

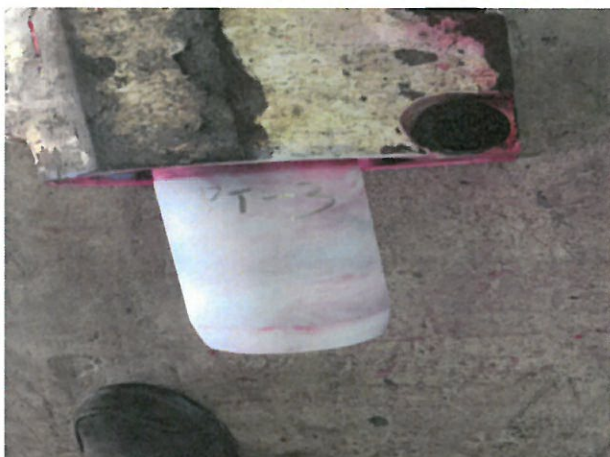
| PT-3 | -- | -- | -- | -- | -- | -- | -- | -- | Acc |

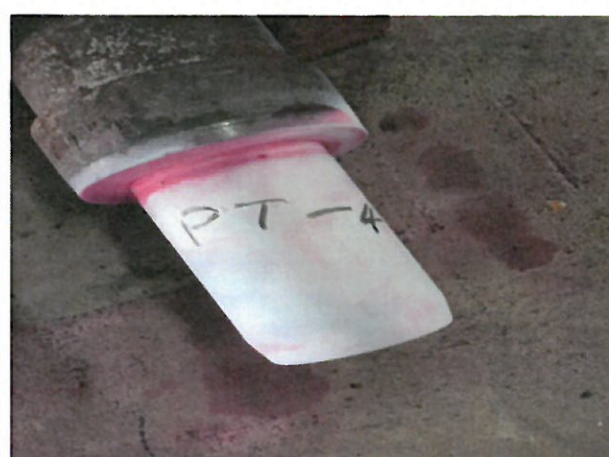
| PT-4 | -- | -- | -- | -- | -- | -- | -- | -- | Acc |

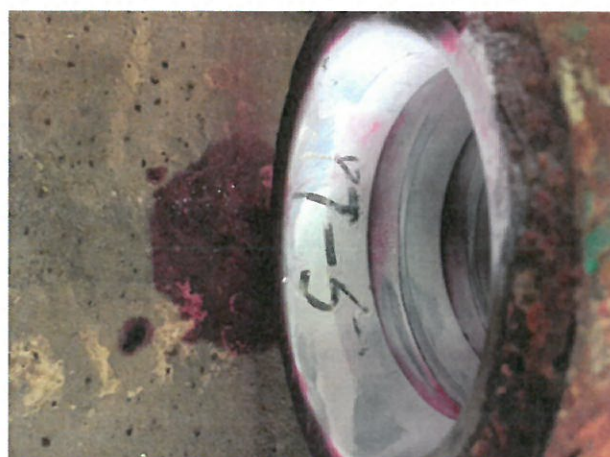
| PT-5 | -- | -- | -- | -- | -- | -- | -- | -- | Acc |

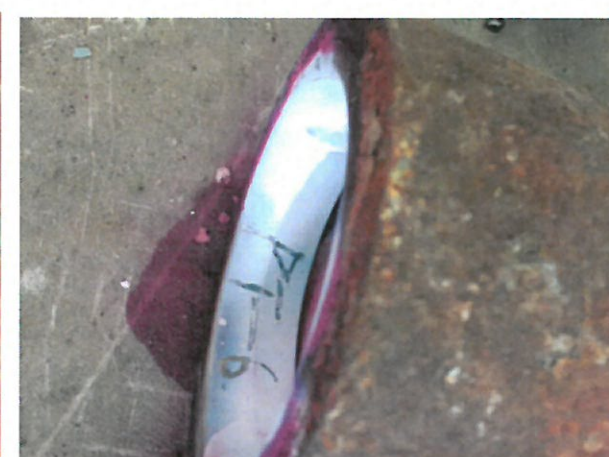
| PT-6 | -- | -- | -- | -- | -- | -- | -- | -- | Acc |
