## 无损检测报告

### NONDESTRUCTIVE TESTING REPORT

工程名称 Project Name: HFL Repair at Workshop

报告编号 Report No. : CJP-WR-051-352-RT001-19-030

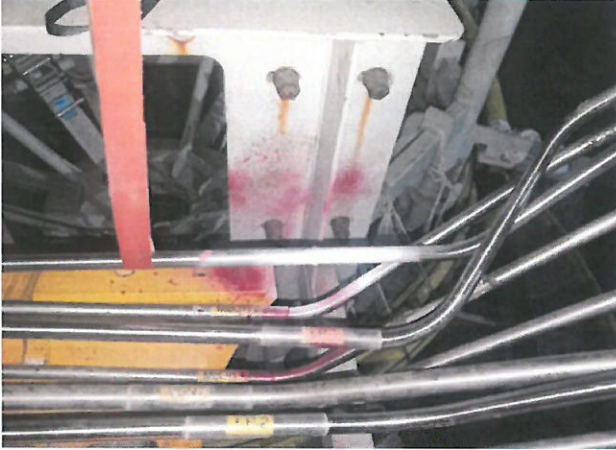
IWO-19-03-A080-1

| 检测地点<br>Test Position | QPOC Workshop | | 放射源<br>Source | XXG-2505 | | 底片黑度<br>Film Density | 2.0~4.0 | | 显影温度<br>Developing Temperature | 20℃ | | |
|---|---|---|---|---|---|---|---|---|---|---|---|---|
| 1 | IWO-19-03-A080 | 1 | -- | A | GTAW | 15.3 | Φ15.3×1.33 | N. S. D | -- | Acc | -- | -- |
| 2 | IWO-19-03-A080 | 1 | -- | B | GTAW | 15.3 | Φ15.3×1.33 | N. S. D | -- | Acc | -- | -- |
| 3 | IWO-19-03-A080 | 1 | -- | C | GTAW | 15.3 | Φ15.3×1.33 | N. S. D | -- | Acc | -- | -- |

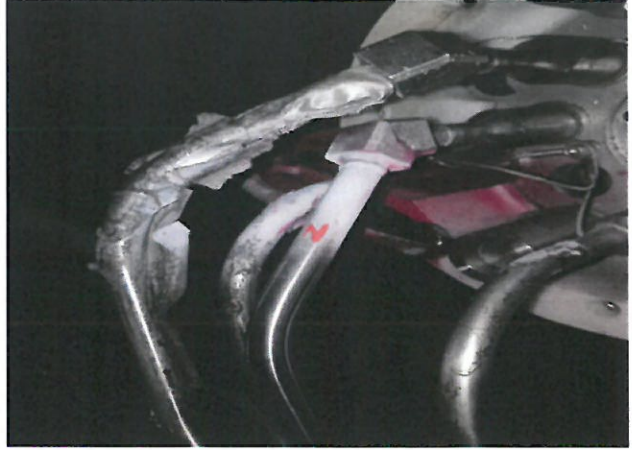
IWO-19-03-A080-2

| 检测地点<br>Test Position | QPOC Workshop | | 放射源<br>Source | XXG-2505 | | 底片黑度<br>Film Density | 2.0~4.0 | | 显影温度<br>Developing Temperature | 20℃ | | |
|---|---|---|---|---|---|---|---|---|---|---|---|---|
| 4 | IWO-19-03-A080 | 2 | -- | A | GTAW | 15.3 | Φ15.3×1.33 | N. S. D | -- | Acc | -- | -- |
| 5 | IWO-19-03-A080 | 2 | -- | B | GTAW | 15.3 | Φ15.3×1.33 | N. S. D | -- | Acc | -- | -- |
| 6 | IWO-19-03-A080 | 2 | -- | C | GTAW | 15.3 | Φ15.3×1.33 | N. S. D | -- | Acc | -- | -- |
